9.0 Appendices

Heritage Asset Management Sheets

Rookwood Archaeological Assessment (AA)

GML Heritage

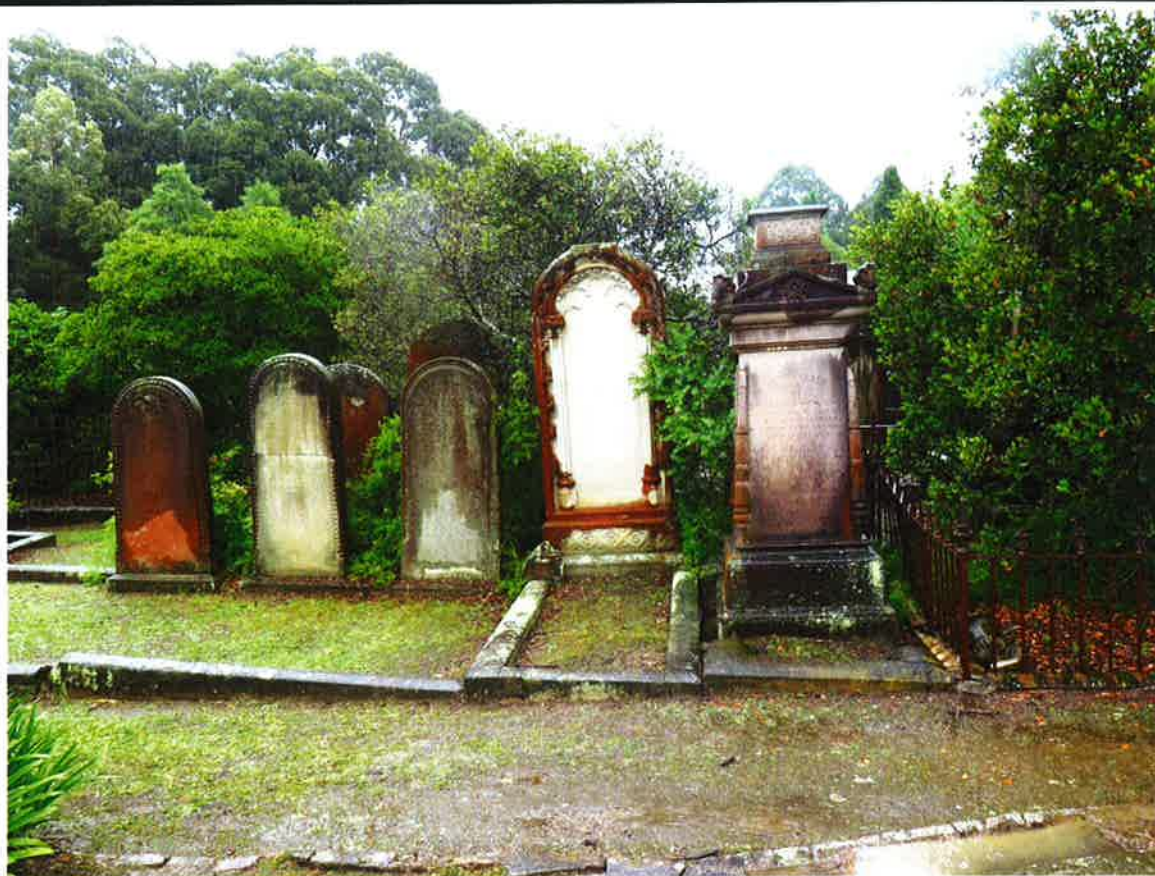
ITEM DETAILS—Wesleyan Section

Name of Item	Wesleyan Section			
Item Type	Cultural landscape			
Precinct	MU:1, Zone: A			
Management Context	Within SHR			
Associated With				
Physical Description	The Old Wesleyan Section is laid out around distinctive circular pathways with well-preserved brick edging. The peripheral plantings of mixed eucalypt and evergreen trees, and visually significant block planting forming a 'gardenesque' setting for exceptional monuments and mausolea. The planting is especially lush, reflecting the ideas of Charles Moore and with representative examples of plant symbolism. The area contains a number of large individual tombs and memorials, many in finely crafted sandstone, from the late 19 th century. A number them (in the eastern sector) were transferred from Devonshire Street Cemetery.			
Historical Background	The Wesleyan Section was part of the original 200 acres, laid out as part of the 1868 Charles Moore plan. By 1893 the Old Wesleyan cemetery was almost full and the community obtained additional 50 acres for burial south of Haslem Drive, in the newly allocated areas. In 1902, the Wesleyan Church in NSW united with other Methodist ministries under the newly formed Methodist Church of Australia, but the Wesleyan congregation, which had grown in size and reach in NSW since 1855, remained dominant.

Conservation Priority Actions	<ul style="list-style-type: none"> Identify key individual vaults and memorials for listing at local level. Priority area for significant tree study. 						
Asset Management Requirements	Do		Don't				
	<ul style="list-style-type: none"> Remove or cut back any vegetation which is causing damage to headstones, graves or monuments, subject to significant tree study and as approved as Site Specific Exemptions. Monitor condition and establish repair priorities to memorials and vaults on a cyclical basis. Ensure any new damage, safety hazard or breakage is notified promptly on detection. Undertake necessary first-aid repairs to collapsed graves, damaged kerbs, railings and other monuments according to conservation principles. Maintain existing gravel paths, including all brick edgings and guttering, to tertiary paths and between graves/plots. Maintain the landscape character of the place by retaining and potentially restoring significant and symbolic plantings of heritage significance on a planned basis, to minimise impact on character and significance. Improve visitor appreciation by limited interpretation and sympathetic wayfinding subject to State Heritage approval. 		<ul style="list-style-type: none"> Allow intensification of burial through renewable tenure. Replace, relocate or remove memorials, parts of memorials, original markers without first assessing significance. Allow new monuments within the section except where approved under specific memorial guidelines for the area approved by the NSW Heritage Council. Allow mechanical excavation and vehicular access to road verges and paths. Permit new excavation or development without considering the heritage impact on the memorial landscape and its values, as well as the site's potential historical archaeological relics. Attempt or allow cleaning, painting, reconstruction or restoration of headstones or inscriptions without heritage advice. Permit new paving, road alterations, facilities, signage or landscaping that may detract from heritage significance of the place and its immediate surroundings. Plant trees, shrubs or flora that are not in keeping with the original landscape character. Reclaim tertiary paths for burial or other development.

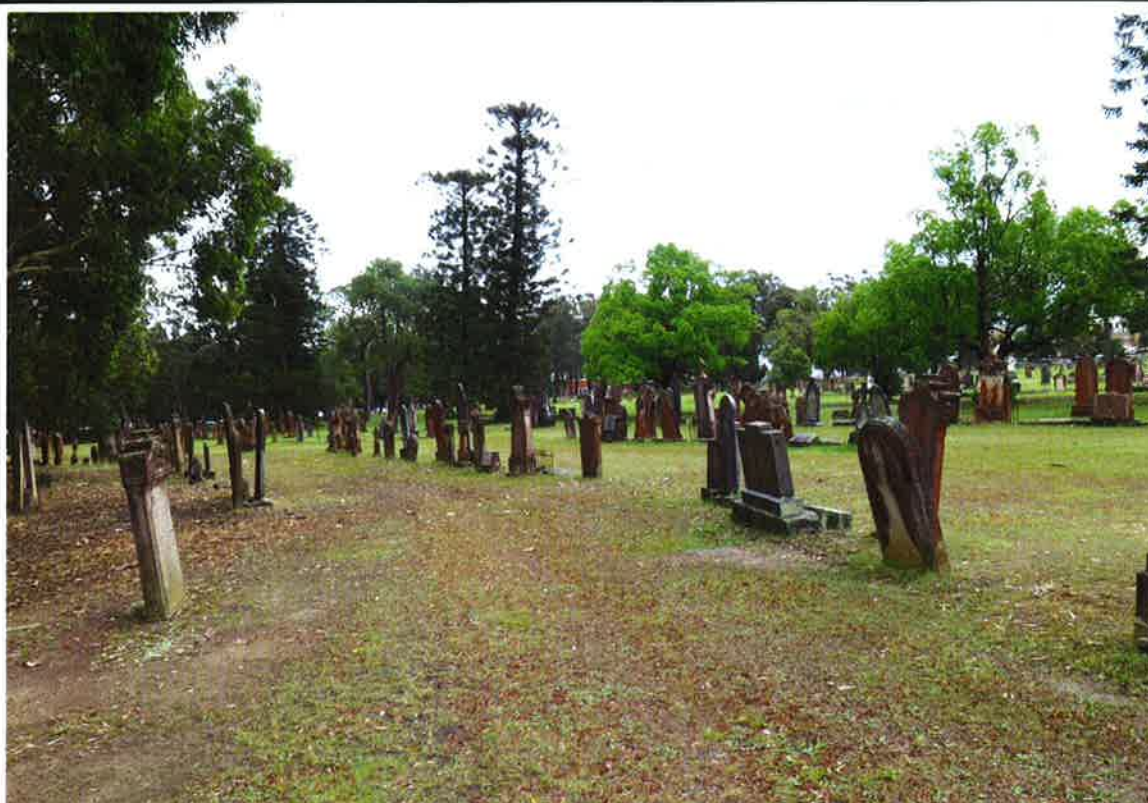
ITEM DETAILS—Old Catholic No. 1

Name of Item	Old Catholic Ground			
Item Type	Cultural Landscape			
Precinct	MU: 2, Zone: CMCT			
Management Context	Within SHR (CMCT)			
Associated With	St Michael's Mortuary Chapel; Railway Loop			
Physical Description	<p>The Old Catholic Ground sits in the north western corner of the Necropolis, bordered by Railway Street to the north and East Street to the west. The alignment of the railway corridor and view to Mortuary Station are reinforced by tree avenues and circulation routes. The density of burials increases closer to the mortuary station. Set in a curvilinear garden layout with a canal running through the section. Burials are marked by historic vaults to the north and west of St Michael's Chapel with religious headstones and other monuments present in the section marking burial locations. Intrusive modern vaults have been built over the railway corridor in the south-east of the section.</p>

Asset Management Requirements	Do <ul style="list-style-type: none"> Remove any vegetation which may obscure or damage headstones, graves or monuments. Monitor condition of graves and monuments and establish repair priorities on a cyclical basis. Ensure any new damage or breakage is addressed immediately on detection. Undertake necessary first-aid repairs to collapsed graves, headstones, damaged kerbs, railings and other monumentation according to conservation principles, without damaging significance. Maintain grass paths between graves/plots for pedestrian access. Maintain secondary and tertiary roads and paths free of infill burial or development. Maintain the landscape character of the place by retaining and potentially restoring avenue plantings to primary, secondary and tertiary circulation routes. Provide appropriate landscape buffering in areas where new burial plots, lawn cemeteries or vaults detract from heritage and landscape character values. 		Don't <ul style="list-style-type: none"> Replace, relocate or remove memorials, parts of memorials, kerbs or original markers without first assessing significance. Allow new monuments, landscaping or plantings to the railway corridor. Allow new monuments within the section except where approved under specific memorial guidelines for the area approved by the NSW Heritage Council. Allow mechanical excavation and vehicular access to road verges and paths. Permit new excavation or development without considering the heritage impact on the memorial landscape and its values, as well as the section's potential historical archaeological relics. Attempt or allow cleaning, painting or restoration of headstones or inscriptions without heritage advice. Permit new paving, road alterations, facilities, signage or landscaping that may detract from heritage significance of the place and its immediate surroundings. Plant trees, shrubs or flora that are not in keeping with the original landscape character. Reclaim tertiary roads for burial or other development.

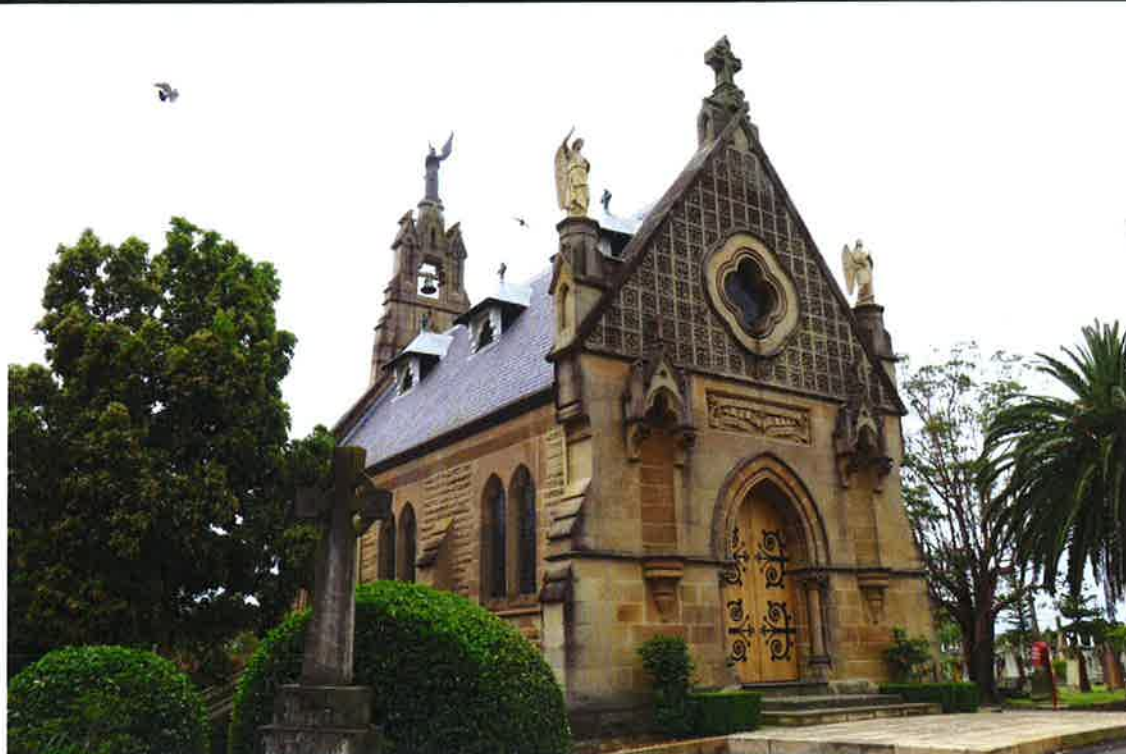
Name of Item	St Michael's Mortuary Chapel			
Item Type	Building			
Precinct	MU:2, Zone CMCT			
Management Context	Within the SHR (CMCT)			
Associated With				
Physical Description	<p>St Michael's Mortuary Chapel is a Victorian Gothic Revival style building constructed of Pyrmont sandstone with a slate roof and internal floors of Kilkenny and Sicilian marble. The northern end features a belltower and semicircular apse and the southern gable features intricately carved stone diaper work around a quatrefoil window. Pairs of stained glass windows are set into the side walls with further stained glass windows in the walls of the northern semicircular apse.</p> <p>The conical roof of the apse along with the main portion of the building is roofed of slate with lead ridging and flashing, with lead sheet roofing over each of the six roof ventilators. The steep pitch of the roof is supported by timber trusses.</p> <p>The internal ceiling consists of timber boarding which is diagonally aligned in V-joins. The floors are black and white marble. The square tiles are arranged in a checkerboard pattern</p> <p>The mortuary chapel stands within extensively landscaped gardens and lawns with monumental headstones as the centrepiece of a distinctive commemorative landscape, with well-kept low hedges, evergreen shrubs and flower beds.</p> <p>The Chapel underwent restoration in 1990 including the modernisation of services within the chapel, and new paving, stormwater and rainwater services.</p>

Asset Management Requirements	Do		Don't		
	<ul style="list-style-type: none"> Maintain the distinctive character of the building and its setting. Conserve the design character and features, including stone masonry ornament and detailing. Monitor the condition through regular inspection and keep secure, clean and weathertight when not in regular use as stipulated by NSW Minimum Standards of Repair for SHR items Ensure that any changes or addition of materials for maintenance or security measures are approved, easily reversible and can be identified on close inspection. Use appropriate cleaning for interior and exterior to ensure maintenance of fabric and associated heritage values Ensure any new damage or breakage is addressed immediately 		<ul style="list-style-type: none"> Replace, relocate or remove any part of the chapel without first assessing significance Damage any fabric on the internal or exterior of the chapel. Allow use of the building which may damage or alter the chapel and associated landscape. Allow any development internally or externally without approval that may have a negative impact on heritage values or structure and fabric. Replace original fabric or elements with unsympathetic modern materials or elements. Allow any nearby works, including vegetation management, access, infrastructure, signage or other minor works to negatively impact on setting and curtilage, principal facades, or relationship to surrounding landscape and layout. Attempt cleaning or restoration of the sandstone, slate roof, stained-glass, interior flooring and finishes, or movable items without heritage advice.

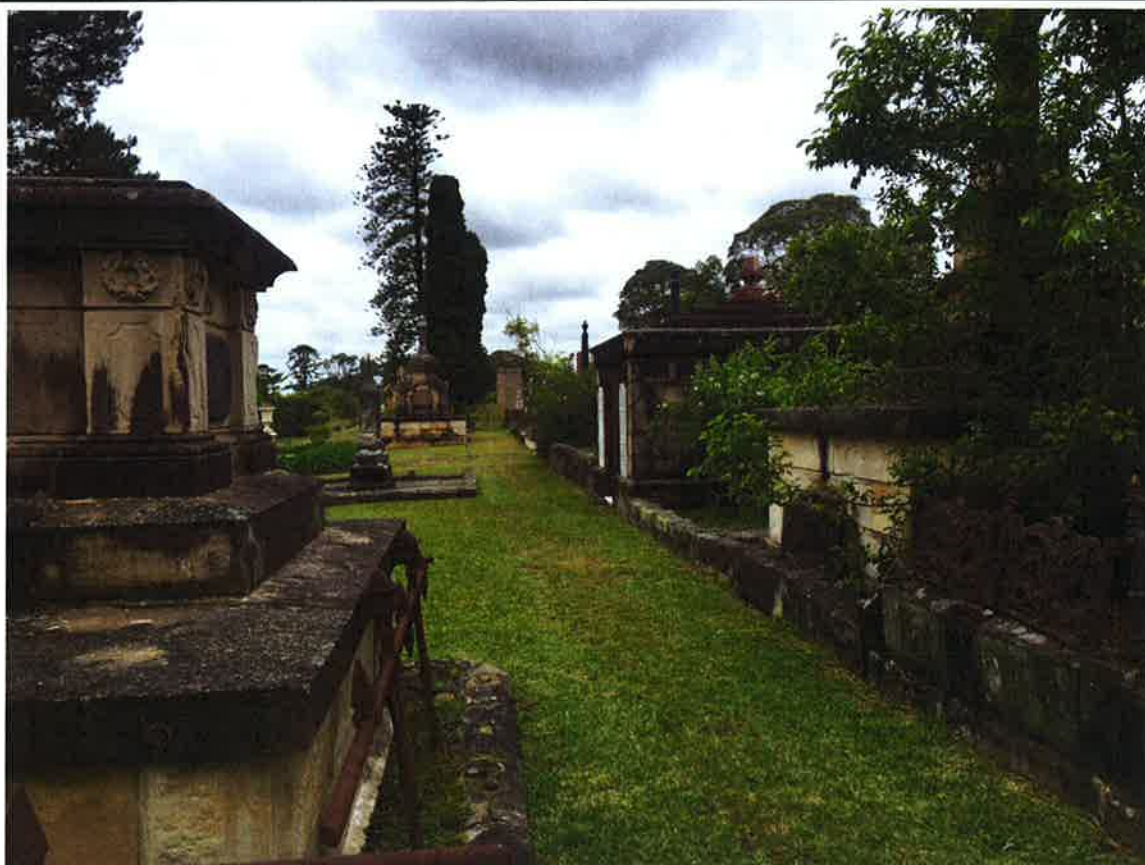
ITEM DETAILS—Old Anglican No. 1

Name of Item	Old Anglican No. 1			
Item Type	Cultural Landscape			
Precinct	MU:3; Zone:B			
Management Context	Within SHR			
Associated With	Anglican Lattice Shelters; Elephant House; Serpentine Canal			
Physical Description	<p>The Old Anglican area is an area of exceptional monumental and landscape heritage in a gridded landscape layout of nodes joined by grass paths. Many of the nodes contain significant landmark elements such as statuary, shelters, trees or ornamental features. The area is centred on a concentration of memorials, vaults and mausolea in the SW corner (in the lots immediately adjacent to Necropolis Circuit/Necropolis Drive). It also includes separate clusters of important Army/Navy graves. The area was located southeast of the Ranger's Lodge (remains of which are in lot B on William Drive) and at the upper end of the Serpentine. There are significant views into the northern part of the area from William Drive. Large hoop and bunya pines and cedar of Lebanon are a feature of the area's planting</p>

Context of Significance	National <input type="checkbox"/>	State <input checked="" type="checkbox"/>	Local <input type="checkbox"/>	N/A <input type="checkbox"/>			
Condition	Excellent <input type="checkbox"/>	Good <input checked="" type="checkbox"/>	Fair <input type="checkbox"/>	Attention Required <input type="checkbox"/>			
Conservation Priority Actions	<ul style="list-style-type: none"> Priority area for significant tree register 						
Asset Management Requirements	Do		Don't				
	<ul style="list-style-type: none"> Remove and control vegetation that may obscure or damage headstones, graves or monuments to preserve landscape integrity Monitor condition and establish repair priorities on a cyclical basis Ensure any new damage or breakage is addressed immediately on detection Undertake necessary first-aid repairs to collapsed graves, damaged kerbs, railings and other monuments according to conservation principles, without damaging significance Maintain grass paths between graves/plots and landmarks/nodes for pedestrian access Maintain the landscape character of the place by retaining and potentially restoring avenue plantings Retain and progressively replace marker trees as identified in the significant tree register Protect the ridgeline views from and towards William Drive Ensure any infrastructure and traffic upgrades to primary roads (Necropolis Ave) take into account the likely heritage impacts to the area Maintain and strengthen linkage between the landmarks and nodes by means of footpaths and sympathetic wayfinding and interpretation 		<ul style="list-style-type: none"> Replace, relocate or remove memorials, parts of memorials or original markers without first assessing significance Allow new monuments within the Old Ground except where approved under burial/memorial guidelines for the area; Remove, alter or damage original and early brick path edging and drainage Attempt or allow cleaning, painting or restoration of headstones or inscriptions without heritage advice Permit new paving, road alterations, facilities, signage or landscaping that may detract from heritage significance of the place and its immediate surroundings Permit new excavation (including for burial) or development without considering the heritage impact on the memorial landscape and its values. Plant trees, shrubs or flora that are not in keeping with the original landscape character Reclaim tertiary roads for burial or other development

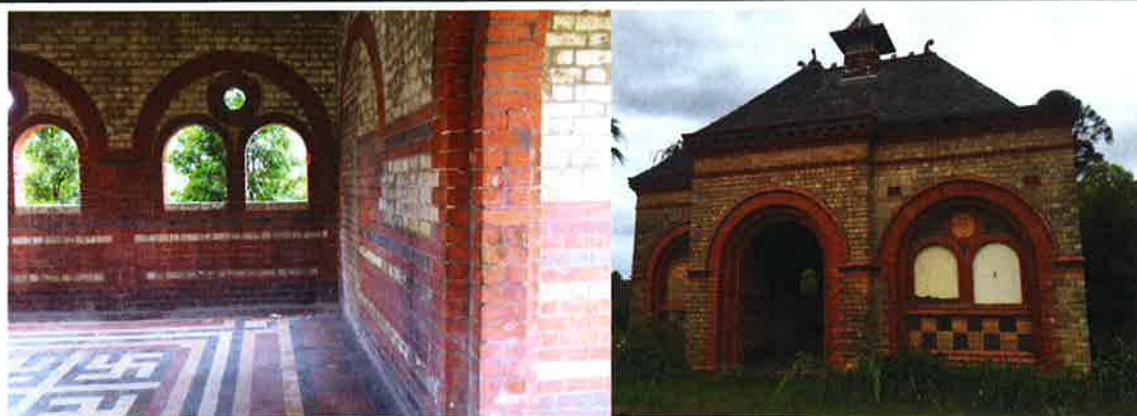
ITEM DETAILS—Elephant House and Devonshire St Gates

Name of Item	Elephant House and Devonshire St Gates (also known as Brick and Slate Rest House and Old Anglican Office).				
Item Type	Building with associated avenue and memorial gates				
Precinct	MU:3, Mgt Zone: B				
Management Context	Within SHR (RGCRT)				
Associated With	Old Anglican Area; Lattice Shelters				
Physical Description	<p>The 'Elephant House' is a brick and slate pavilion with Romanesque style influences at the N end of a tree lined north-south axis, with the Devonshire St Gates at the other end. The shelter is built to a cruciform plan with a steeply pitched hipped roof with patterned slates cresting at the apex of the roof. A roof vent is fitted to the centre of the roof. There are two round-arched openings with round-arched windows set into the walls either side of the entrances. The walls are tuck-pointed brickwork in red, buff, black and cream. The internal floors are covered with squared tiles arranged in a geometric design in four colours matching the brick work.</p> <p>The building is situated on the outer edge of the old Anglican area laid out by Maiden. It has formal spatial connections, via grass paths, with the Anglican timber lattice shelters. The Devonshire St Gates were removed to Rookwood along with numerous monuments and hundreds of graves ca.1888.</p>

<p>Requirements</p>	<ul style="list-style-type: none"> • Maintain the distinctive character of the building and its setting. • Conserve the visual link and restore sympathetic avenue planting to the Devonshire Street Gates. • Conserve the decorative design and form of the slate roof, tuck pointing, polychrome brickwork and tile floor. • Monitor the condition through regular inspection and keep secure, clean and weathertight when not in regular use as stipulated by NSW Minimum Standards of Repair for SHR items. • Ensure that any changes or addition of materials for maintenance or security measures are approved, easily reversible and can be identified on close inspection. • Use appropriate cleaning for interior and exterior to ensure maintenance of fabric and associated heritage values. • Keep vegetation maintained in a way that respects the aesthetic values and symmetry of the building, with heritage advice as required. • Conserve and maintain the Devonshire iron gates painted, rust free and in working condition. 	<ul style="list-style-type: none"> • Add, replace or remove fabric without first understanding potential impact on the heritage values. • Remove elements of heritage value unless this is essential for safety, structural or operational reasons, and following advice from heritage specialists. • Replace original fabric with different materials. • Attempt cleaning or restoration of brick or stone masonry or interior surfaces without heritage advice. • Remove any vegetation from the beds around the building without understanding impact on heritage values and potential structural risks. • Introduce new uses or facilities without considering heritage impacts and approval processes.

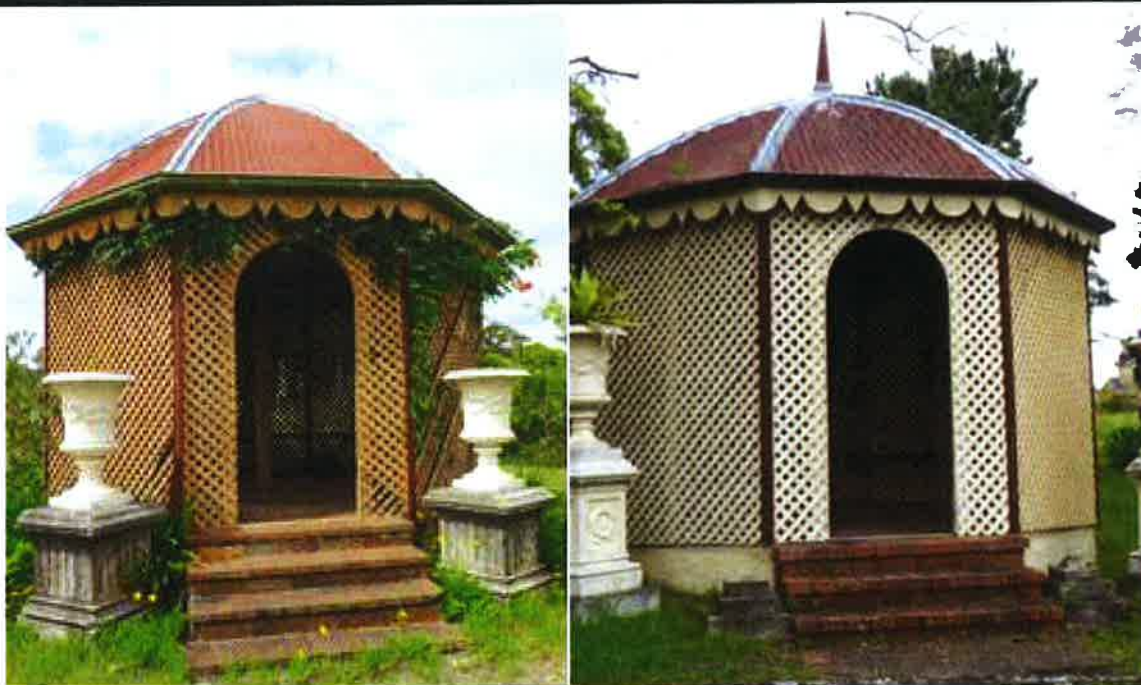
ITEM DETAILS—Anglican Lattice Shelters

Name of Item	Anglican Lattice Shelters			
Item Type	Building Group (2)			
Precinct	MU:3, Zone: B			
Management Context	Within SHR			
Associated With	Serpentine Canal; Old Anglican Area			
Physical Description	<p>Shelter 1: located near the southern end of the Serpentine Canal in the Old Anglican section. A small octagonal lattice-clad shelter approximately 4 meters in diameter. The timber frame is built upon a built-up brick base. Brick steps lead up to the arched opening on the east side of the shelter. The decorative timber fascia has chamfered lower edges. The internal seating is made of timber slats that are bracketed off 7 sides. The roof is corrugated steel sheeting with stop-chamfered rafters with a curved profile. The entrance is flanked by two terracotta urns on square pedestals.</p> <p>Shelter 2: a small octagonal lattice-clad pavilion approximately 4 meters in diameter. The timber frame sits on a built up base with brick edging. Brick steps lead up to an arched opening on the northern side of the shelter. The internal seating on seven sides is made up of timber slats. The original decorative timber fascia has chamfered lower edges and a central square timber post at the center to support the corrugated steel sheeting. The rafters are stop-chamfered with a convex profile and a quad profile on the gutters.</p> <p>The steps are flanked by terracotta urns on square pedestals and the vegetation of the Anglican section surrounds the shelter on all but the northern side.</p>

Historical Background	<p>Shelter 1 and 2 were originally built in the 1890s during the late Victorian period in Rookwood as an important element in the picturesque landscape in the older sections of Rookwood. The structures mostly survived but due to vandalism in the 20th century were partially rebuilt c. 2000.</p> <p>A third shelter of similar design is located in Unit 5. It is thought to have been constructed c. 2002 and is aesthetically related to the earlier lattice shelters in the Old Anglican section. It is not of high historic significance but should be managed and maintained as it has some contributory value.</p>			
Heritage Significance	Historic <input checked="" type="checkbox"/>	Historical Association <input type="checkbox"/>	Aesthetic <input checked="" type="checkbox"/>	Social <input checked="" type="checkbox"/>
	Technical/Research <input type="checkbox"/>	Representativeness <input checked="" type="checkbox"/>	Rarity <input type="checkbox"/>	Integrity <input type="checkbox"/>

Victorian period.				
Level of Significance	Exceptional <input type="checkbox"/>	High <input checked="" type="checkbox"/>	Moderate <input type="checkbox"/>	Little <input type="checkbox"/>	None <input type="checkbox"/>
Context of Significance	National <input type="checkbox"/>	State <input type="checkbox"/>	Local <input checked="" type="checkbox"/>	N/A <input type="checkbox"/>	
Condition	Excellent <input type="checkbox"/>	Good <input checked="" type="checkbox"/>	Fair <input type="checkbox"/>	Attention Required <input type="checkbox"/>	
Conservation Priority Actions					
Asset Management Requirements	Do		Don't		
	<ul style="list-style-type: none"> • Maintain the distinctive character of the buildings and their setting. • Cut back any vegetation that poses a risk of damage to the building fabric. • Use like for like materials during essential roofing, cladding and rainwater repairs. • Monitor the condition through regular inspection and keep secure, clean and weathertight and free of rubbish. • Ensure that any changes or addition of materials for maintenance or security measures are approved, easily reversible and can be identified on close inspection. • Make safe from vandalism and fire without destroying the building fabric; control damage by birds and vermin where reasonably practicable without impacting on significance. • Reinstate the landscape setting and reduce risks to fabric by undertaking appropriate tree maintenance without harming significant planting patterns and features. 		<ul style="list-style-type: none"> • Replace, demolish or remove fabric without first understanding potential impact on the heritage values. • Remove elements of heritage value unless this is essential for safety, structural or operational reasons, and only on advice from qualified heritage specialists. • Replace original fabric with unsympathetic modern materials. • Attempt cleaning, emergency repair or restoration of without seeking advice from qualified heritage specialists on appropriate methods. • Make alterations to interior/ exterior appearance, fixtures or structure without heritage advice. • Allow any fire prevention upgrades that are unsympathetic to its heritage values and informal character.

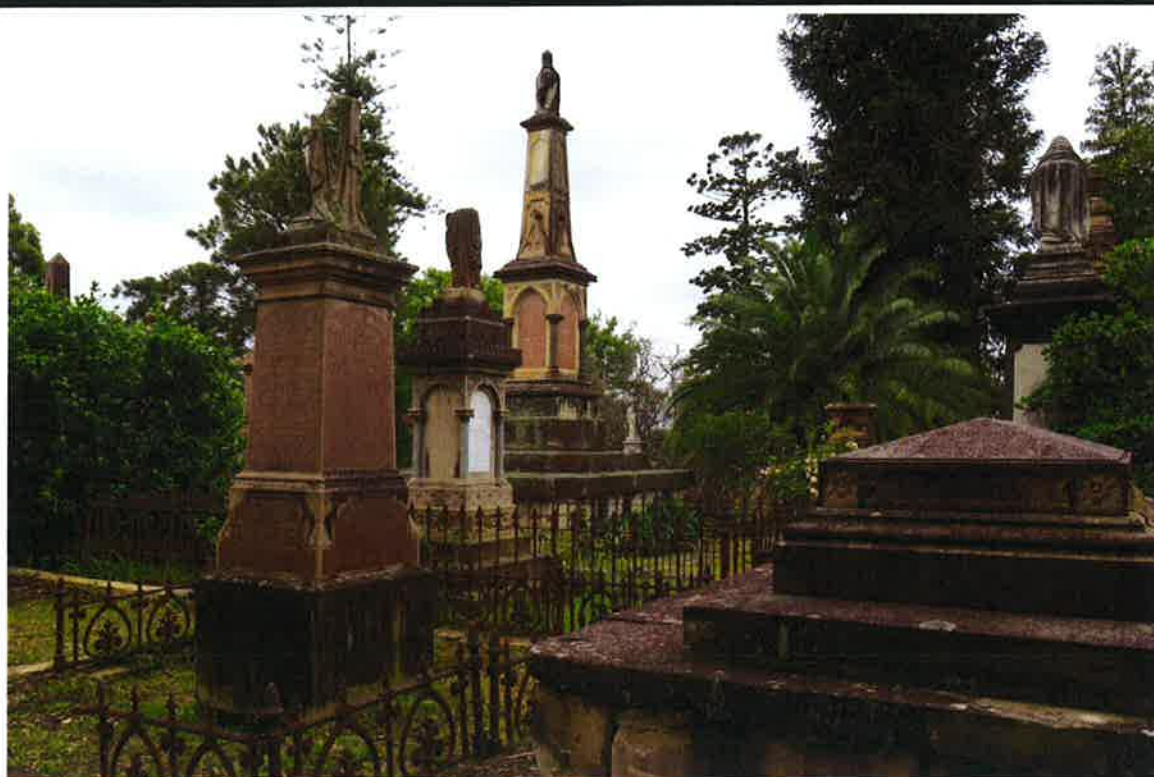
ITEM DETAILS—Old Presbyterian Section

Name of Item	Old Presbyterian Section			
Item Type	Cultural Landscape			
Precinct	MU:8, Zone: A			
Management Context	Within SHR			
Associated With	Frazer Mausoleum			
Physical Description	<p>The Old Presbyterian Section sits within the south western portion of the SHR area. The area slopes from its high point at Necropolis circuit towards the boundary on East street. An early historic sign identifies the section at the edge of Necropolis Circuit. A brick canal from unit 11 leads through the south west of the area to empty into a drain at the east street perimeter.</p> <p>The original layout of the cemetery is visible in the intricately patterned circular brick layout and contains predominantly 19th century burials. The higher central and eastern end of the section, near Necropolis Circuit is dominated by large intact family vaults. These are in the gothic style and arranged in the circular and cruciform pattern. The Frazer mausoleum is the dominating feature on the landscape. There are numerous unusual graves within the area, with various cast iron fences, sandstone surrounds and stone obelisks. The density of the burials decreases further away from the Necropolis Circuit. Most of the stelae in the area are sandstone, interspersed with some in marble and granite.</p> <p>The planting is lush, reflecting the gardenesque planting ideas of the early cemetery designers, and with representative examples of plant symbolism. The southern and western extent of the section is predominately regenerated original native woodland while the mid-upper area is defined by neatly mown lawns with some native grasses and Watsonia growth in burial plots.</p>

Context of Significance	National <input type="checkbox"/>	State <input checked="" type="checkbox"/>	Local <input type="checkbox"/>	N/A <input type="checkbox"/>			
Condition	Excellent <input type="checkbox"/>	Good <input checked="" type="checkbox"/>	Fair <input type="checkbox"/>	Attention Required <input type="checkbox"/>			
Conservation Priority Actions	<ul style="list-style-type: none"> Identify key individual vaults for listing at local level Conduct detailed condition assessment of key memorial vaults and structures and develop a long term program or prioritised work Priority area for significant tree study 						
Asset Management Requirements	Do		Don't				
	<ul style="list-style-type: none"> Remove or cut back any vegetation which may damage headstones, graves or monuments. Retain the lush vegetated character of the area as much as possible (e.g. encourage creepers, mature shrubs and natural grasses where these are not detrimental to fabric). Monitor condition and establish repair priorities on a cyclical basis. Ensure any new damage, safety hazard or breakage is addressed promptly on detection. Undertake necessary first-aid repairs to collapsed graves, damaged kerbs, railings and other monuments according to conservation principles. Maintain limited grass paths between graves/plots for pedestrian access. Maintain the landscape character of the place by retaining and potentially restoring significant and symbolic plantings of heritage significance on a planned basis, to minimise impact on character and significance. 		<ul style="list-style-type: none"> Replace, relocate or remove memorials, parts of memorials, original markers without first assessing significance. Allow new monuments within the section except where approved under specific memorial guidelines for the area approved by the NSW Heritage Council. Allow mechanical excavation and vehicular access to road verges and grassed drive. Permit new excavation (including for burial) or development without considering the heritage impact on the memorial landscape and its values. Attempt or allow cleaning, painting or restoration of headstones or inscriptions without heritage advice. Permit new paving, road alterations, facilities, signage or landscaping that may detract from heritage significance of the place and its immediate surroundings. Plant trees, shrubs or flora that are not in keeping with the original landscape character. Reclaim tertiary roads for burial or other development.

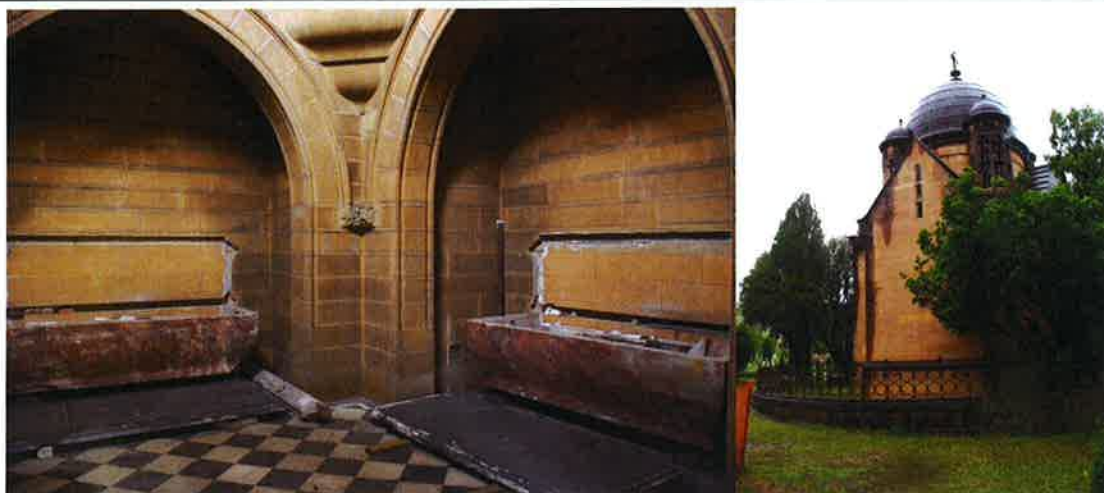
Name of Item	Frazer Mausoleum (or Frazer Vault)			
Item Type	Building			
Precinct	MU:8, Zone: A			
Management Context	Within SHR			
Associated With	Old Presbyterian Section			
Physical Description	<p>The mausoleum does not fit any distinctive stylistic categories. It consists of a building in a cross form, with all transects of equal lengths. Loadbearing sandstone walls support the dome of the roof with high leadlight windows over each of the pendentives of the dome as well as small windows positioned in the gables.</p> <p>The entry sits on the South transect/side of the building with decorated bronze doors. An alloy copper crucifix sits at the apex of the dome.</p> <p>The interior of the Mausoleum contains a narrow entry vestibule and three sarcophagi with copper alloy feet. These are located in individual niches with wide pointed arches and commemorative tablets. The interior of the building has a marble tiled floor and moulding embellishes the transepts</p> <p>The paving outside the front entrance is a checkerboard pattern of light and dark stone times with two Chinese Mourning Cypress planted on either side of the entry and many other trees and shrubs that, combined with the landscape curtilage, reflect the nineteenth century views on what was considered acceptable form, character and vegetation for a funerary landscape.</p> <p>Some self-sown trees and shrubs are also established within the curtilage for the Frazer mausoleum and subsequently diminish the views available of the mausoleum</p> <p>The mausoleum is enclosed of fencing consisting of a sandstone plinth topped with a wrought iron balustrade decorated with flowers in varying stages of bloom</p>

Condition	Excellent <input type="checkbox"/>	Good <input type="checkbox"/>	Fair <input checked="" type="checkbox"/>	Attention Required <input checked="" type="checkbox"/>			
Conservation Priority Actions	<ul style="list-style-type: none"> Develop a program of conservation work within 5 years, with heritage advice 						
Asset Management Requirements	Do		Don't				
	<ul style="list-style-type: none"> Maintain the distinctive character of the building and its setting. Retain and conserve the contents in situ including all fixtures and fittings. Conserve the design character and features, including stone masonry ornament and detailing. Monitor the condition through regular inspection and keep secure, clean and weathertight when not in regular use as stipulated by NSW Minimum Standards of Repair for SHR items Ensure that any changes or addition of materials for maintenance or security measures are approved, easily reversible and can be identified on close inspection. Use appropriate cleaning for interior and exterior to ensure maintenance of fabric and associated heritage values Ensure any new damage or breakage is addressed immediately. Ensure keys are duplicated and safely stored. Ensure any works to the interior or exterior fabric including sarcophagi are undertaken on the advice of a stone conservation expert. 		<ul style="list-style-type: none"> Replace, relocate or remove any part of the chapel without first assessing significance Damage any interior or exterior fabric, including fencing and paving. Allow any development internally or externally without approval that may have a negative impact on heritage values or structure and fabric. Replace original fabric or elements with unsympathetic modern materials or elements. Allow any nearby works, including vegetation management, access, infrastructure, signage or other minor works to negatively impact on setting and curtilage, principal facades, or relationship to surrounding landscape and layout. Attempt cleaning or restoration of the sandstone, slate roof, stained-glass, interior flooring and finishes, or movable items without heritage advice.

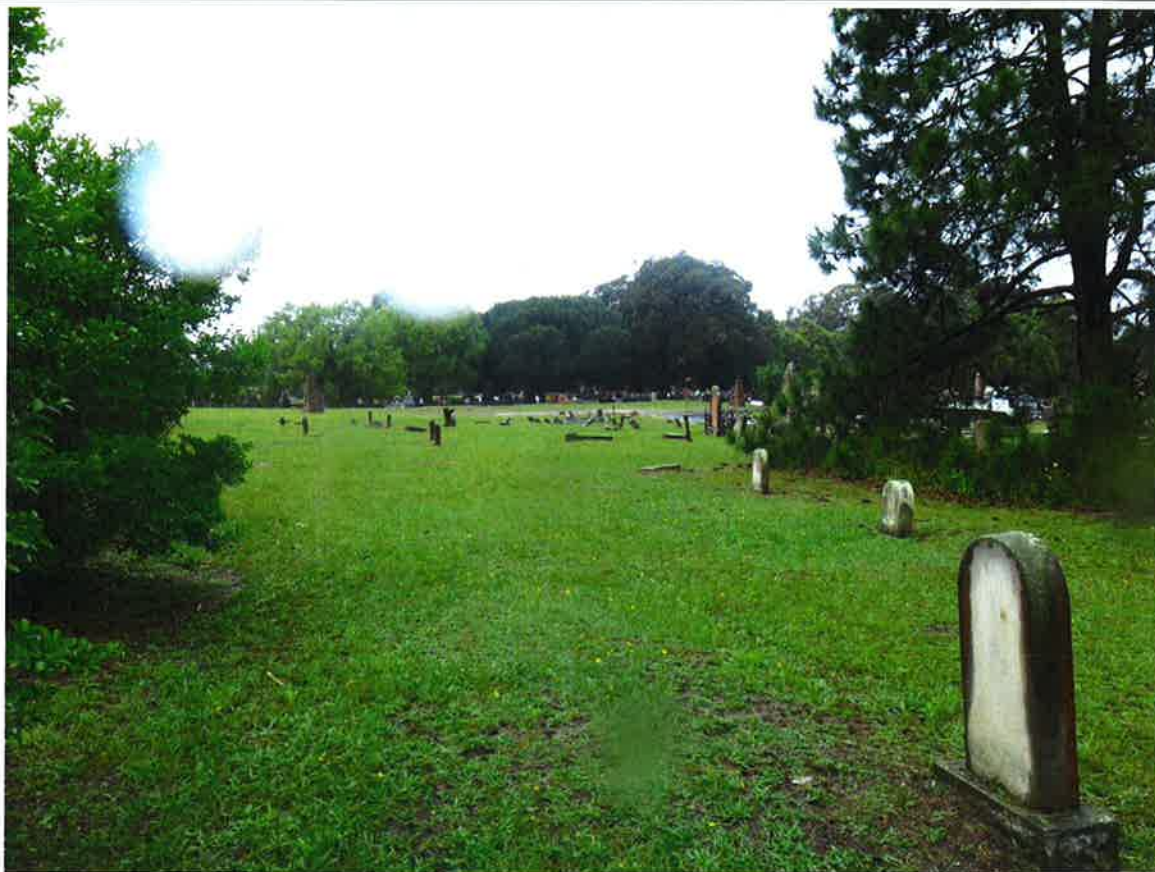
ITEM DETAILS—Old General No.1

Name of Item	Old General No.1			
Item Type	Cultural Landscape			
Precinct	MU: 8A; Zone: A			
Management Context	Non SHR (located on land adjoining SHR)			
Associated With	Quong Sin Tong Memorial			
Physical Description	The most significant aspect of the Old General No.1 section is the 'Old Chinese' burial ground. This has headstones of a standard type with Chinese inscriptions, in a widely spaced layout, surrounding the Quong Sin Tong monument. The area is likely to include a number of unmarked graves and has visible signs of disturbance resulting from the disinterment of Chinese for return to China, in accordance with Chinese custom at the time. Several non-Chinese graves are located closer to Barnet Avenue, including the Bee Miles memorial.			
Historical Background	Reference was first made to a Chinese Section in 1873, although several Chinese burials had been recorded at Rookwood since 1868. The Chinese community had petitioned the Government for a separate section, and the trustees of the General section set aside 3 acres immediately south of the mortuary station circle for Chinese burials. Although no temple was permitted, a residence for a caretaker was allowed (although it does not appear to have been built) and a brazier for burning offerings was also permitted. As was customary, bodies of those Chinese dead who could afford the burial ceremony were temporarily buried at Rookwood prior to their disinterment and removal to China for a traditional burial. Of approximately 1000-2000 burials in this section, up to one third were removed to China in the years before 1949.

Asset Management Requirements	Do		Don't				
	<ul style="list-style-type: none"> Maintain the open landscape character of the place, especially the visual link with the Quong Sin Tong monument. Remove any vegetation which may obscure or damage headstones, graves or monuments. Seek heritage advice before planning any further landscaping around the Quong Sin Tong, or remedial works in and around the grave plots. Undertake necessary first-aid repairs to collapsed graves, headstones, damaged kerbs and other monumentation according to conservation principles, without damaging significance. Monitor condition of graves and monuments and establish repair priorities on a cyclical basis. 		<ul style="list-style-type: none"> Replace, relocate or remove headstones without assessing heritage impact. Allow new monuments within the section except where approved under specific memorial guidelines for the area . Damage headstones with lawn mowing or maintenance equipment. Drive vehicles onto the burial ground or verge. Permit new excavation or development without considering the heritage impact on the memorial landscape and its values, as well as the section's potential historical archaeological relics. Attempt or allow cleaning, painting or restoration of headstones or inscriptions without heritage advice. Extend shrubbery or permit new, infill or feature planting, paving, road alterations, or other facilities that may detract from heritage significance. Permit new paving, road alterations, facilities, signage or landscaping that may detract from heritage significance of the place and its immediate surroundings. Plant trees, shrubs or flora that are not in keeping with the original landscape character. Create new roads or subdivisions in the area that could impact on its landscape character and significance.

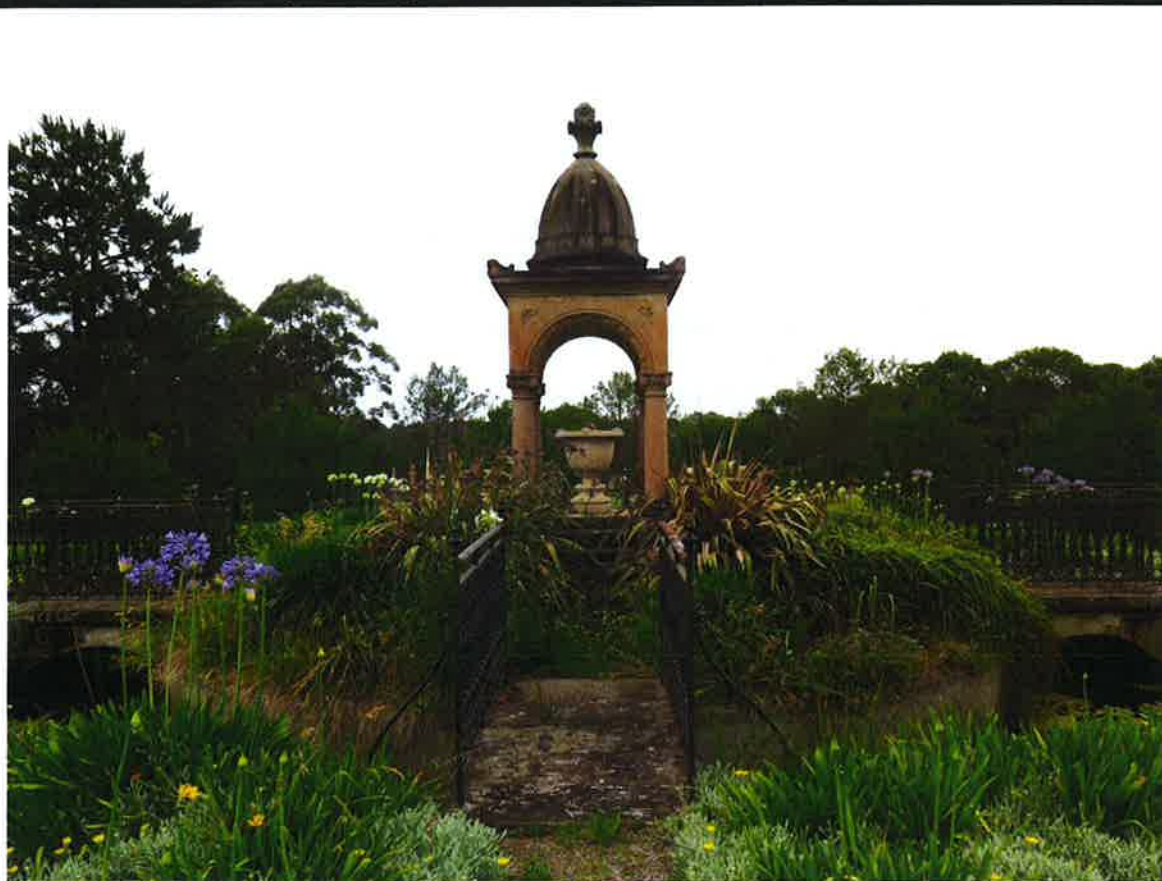
ITEM DETAILS—Quong Sin Tong Monument

Name of Item	Quong Sin Tong Monument
Item Type	Monument
Precinct	MU: 8A, Zone: A
Management Context	Non SHR (RGCRT).
Associated With	Old Chinese Sections, adjacent to the SHR Area in a sector originally identified for inclusion in the SHR listing.
Physical Description	<p>The monument sits on a podium within a circular moat. Four brick arched rendered bridges give access to the monument with sandstone slabs for the bridges. Wrought iron posts serve as balustrades. Most of the original cast iron balustrading has been lost and since replaced with similar design. A brick retaining wall on the inner side of the moat runs between the bridges. Four sets of steps, one on each side, lead up onto the podium of the monument, where an urn under the canopy.</p> <p>The monument has four monolith shafted columns which serve as supports for the ciborium-like monolithic roof. Two stones, set in north and south, form the cornice which supports a pavilion roof block. The monolithic upper dome section is topped with an ornate finial. The monument has an overall European monumental form and style, with Chinese inscriptions on the dome.</p> <p>The moat and surrounding edges are heavily planted with Agapanthus on the outer rim and grass and reeds growing on the island of the monument and in the water of the moat.</p> <p>The urn in the centre is a replacement. The original is located in the stone mason's shed.</p>

Level of Significance	Exceptional <input type="checkbox"/>	High <input checked="" type="checkbox"/>	Moderate <input type="checkbox"/>	Little <input type="checkbox"/>	None <input type="checkbox"/>
Context of Significance	National <input type="checkbox"/>	State <input checked="" type="checkbox"/>	Local <input type="checkbox"/>	N/A <input type="checkbox"/>	
Condition	Excellent <input type="checkbox"/>	Good <input type="checkbox"/>	Fair <input checked="" type="checkbox"/>	Attention Required <input type="checkbox"/>	
Conservation Priority Actions	<ul style="list-style-type: none"> • Update the 2003 CMP to cover the Monument and associated Chinese Burial Ground with specific policies for management that respect the all heritage values. 				
Asset Management Requirements	Do		Don't		
	<ul style="list-style-type: none"> • Maintain centrality of the monument as a landmark in the old Chinese cemetery. • Control weeds in and around the monument and moat to ensure survival of all significant fabric. • Maintain the moat, access bridge and curtilage in accordance with culturally appropriate design and management principles. 		<ul style="list-style-type: none"> • Allow additional plaques or inscription on the monument in any language. • Alter or remove fabric without first understanding potential impact on the heritage values, including those relating to traditional Feng Shui practices. • Use correctly matched mortars and other materials during maintenance or repair. • Carry out remedial works to stonework without heritage advice (other than low pressure water cleaning).

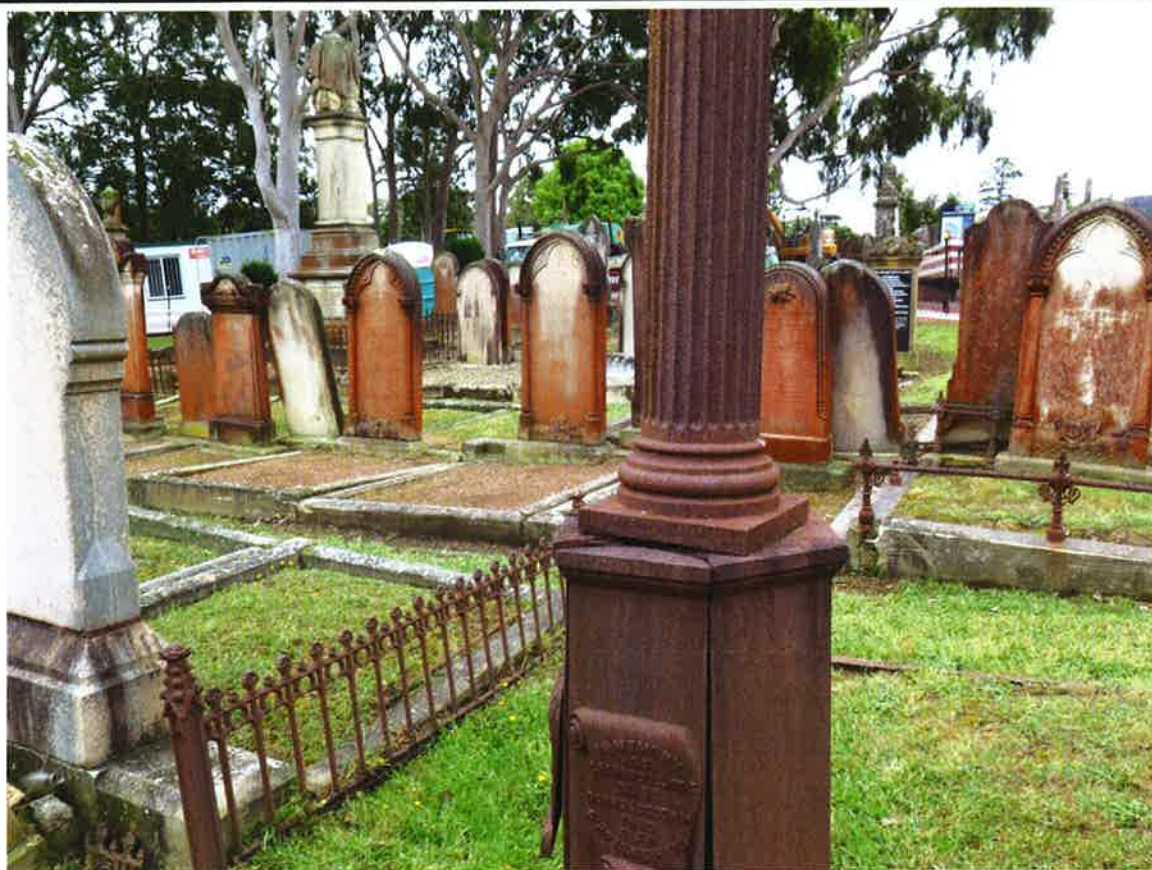
ITEM DETAILS—Old Independent Section

Name of Item	Old Independent Section			
Item Type	Cultural landscape			
Precinct	MU: 12, Zone A			
Management Context	Within SHR (RGCRT)			
Associated With	Jewish Old Ground; Independent Office			
Physical Description	<p>The Old Independent section is located on the main Rookwood ridgeline, with the original layout of intricate circular forms and teardrop shapes defined by brick kerbs and gutters still intact. The radiating burial pattern from mortuary station 1 is still seen through the old independent and attached old Jewish ground; however the alignment of burials in the Old Independent section follows the geometry of the landscaping. The independent office sits within the eastern portion of the section. The old circulation routes are grassed over with Canary Island Date palms and pines defining the landscape pattern. Many of the monuments within the Old Independent section form landmarks from the existing circulation route along Necropolis Drive, Necropolis Circuit. Monuments are mostly sandstone stelae, with some intricate cast iron railings and kerbs, or vaults, most of which are of high quality. The original sign for the independent section remains at the edge of the Necropolis circuit.</p>

Condition	Excellent <input type="checkbox"/>	Good <input checked="" type="checkbox"/>	Fair <input type="checkbox"/>	Attention Required <input type="checkbox"/>			
Conservation Priority Actions	<ul style="list-style-type: none"> Repair damaged kerb sets and monuments on a planned basis. 						
Asset Management Requirements	Do		Don't				
	<ul style="list-style-type: none"> Remove or cut back any vegetation which is causing damage to headstones, graves or monuments, subject to significant tree study and as approved as Site Specific Exemptions. Monitor condition and establish repair priorities to memorials and vaults on a cyclical basis. Ensure any new damage, safety hazard or breakage is notified promptly on detection. Undertake necessary first-aid repairs to collapsed graves, damaged kerbs, railings and other monuments according to conservation principles. Maintain grass and gravel paths between graves/plots for pedestrian access. Maintain the landscape character of the place by retaining and potentially restoring areas of original plantings. 		<ul style="list-style-type: none"> Allow intensification or renewable interment. Replace, relocate or remove memorials, parts of memorials, original markers without first assessing significance. Allow new burials or monuments within the section except where approved under specific burial/memorial guidelines for the area approved by the NSW Heritage Council. Damage headstones with landscape or memorial maintenance equipment. Allow mechanical excavation and vehicular access to road verges and grassed drives. Excavate in the vicinity of the Sexton's House or other buried archaeological relics. Attempt or allow cleaning, painting or restoration of headstones or inscriptions without heritage advice. Permit new paving, road alterations, facilities, signage or landscaping that may detract from heritage significance of the place and its immediate surroundings Plant trees, shrubs or flora that are not in keeping with the original landscape character. Reclaim tertiary roads for burial.
