9.0 Appendices

Heritage Asset Management Sheets

Rookwood Archaeological Assessment (AA)

GML Heritage

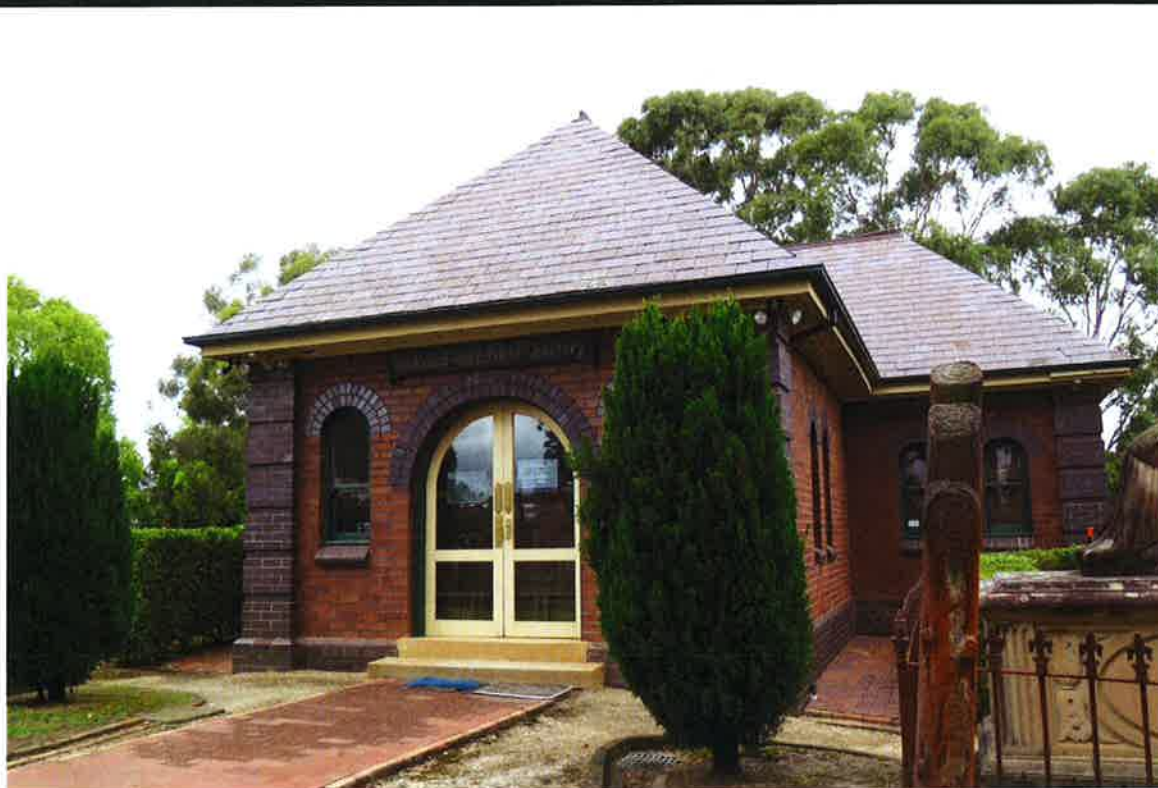
ITEM DETAILS—Independent Office

Name of Item	Independent Office		
Item Type	Building		
Precinct	MU: 12, Zone A		
Management Context	Within SHR		
Associated With	Independent Section; Jewish Old Ground		
Physical Description	<p>The independent office and residence is a brick building from the Interwar Period, located in the Old Independent Section on the eastern side. the building has a symmetrical form on a cruciform floor plan. The external corners of the walls are emphasised with brick quoins in a darker contrasting colour. The walls have cavity brickwork with external tuck-pointing. Windows are timber and double hung and the external door openings have darker brick lintels within the semicircular arched heads.</p> <p>The steep-pitched roof is clad with grey slates with mitred joints at the hips and boarded timber eaves and soffits with brackets at the corners.</p> <p>The internal flooring is concrete with tiled and carpet finishes. There is a plasterboard ceiling with composite timber and plaster covered cornice in the front office space.</p> <p>The office sits within the old independent section and has manicured gardens, including topiary hedges leading up to and abutting the building.</p>

Asset Management Requirements	Do <ul style="list-style-type: none"> Maintain the distinctive character of the building and its setting. Manage shrubberies and hedges around the building in a way that is appropriate to the classical, formal planting style of the period. Conserve the design character and features, including the slate roof, tuck pointing, and coloured brickwork. Monitor the condition through regular inspection and keep secure, clean and weathertight when not in regular use as stipulated by NSW Minimum Standards of Repair for SHR items. Ensure that any changes or addition of materials for maintenance or security measures are approved, easily reversible and can be identified on close inspection. Use appropriate cleaning for interior and exterior to ensure maintenance of fabric and associated heritage values. 		Don't <ul style="list-style-type: none"> Replace or remove fabric without first understanding potential impact on the heritage values. If fabric must be altered for safety, structural or operational reasons, obtain advice from heritage specialists, with OEH approval if required. Replace original fabric or elements with unsympathetic modern materials or elements. Do not allow any nearby works, including vegetation management, access, infrastructure, signage or other minor works to negatively impact on setting and curtilage, principal facades, or relationship to surrounding landscape and layout. Attempt cleaning or restoration of the masonry or interior floor surfaces without seeking advice for appropriate methods. Allow any development internally or externally without approval that may have a negative impact on heritage values or structure and fabric.

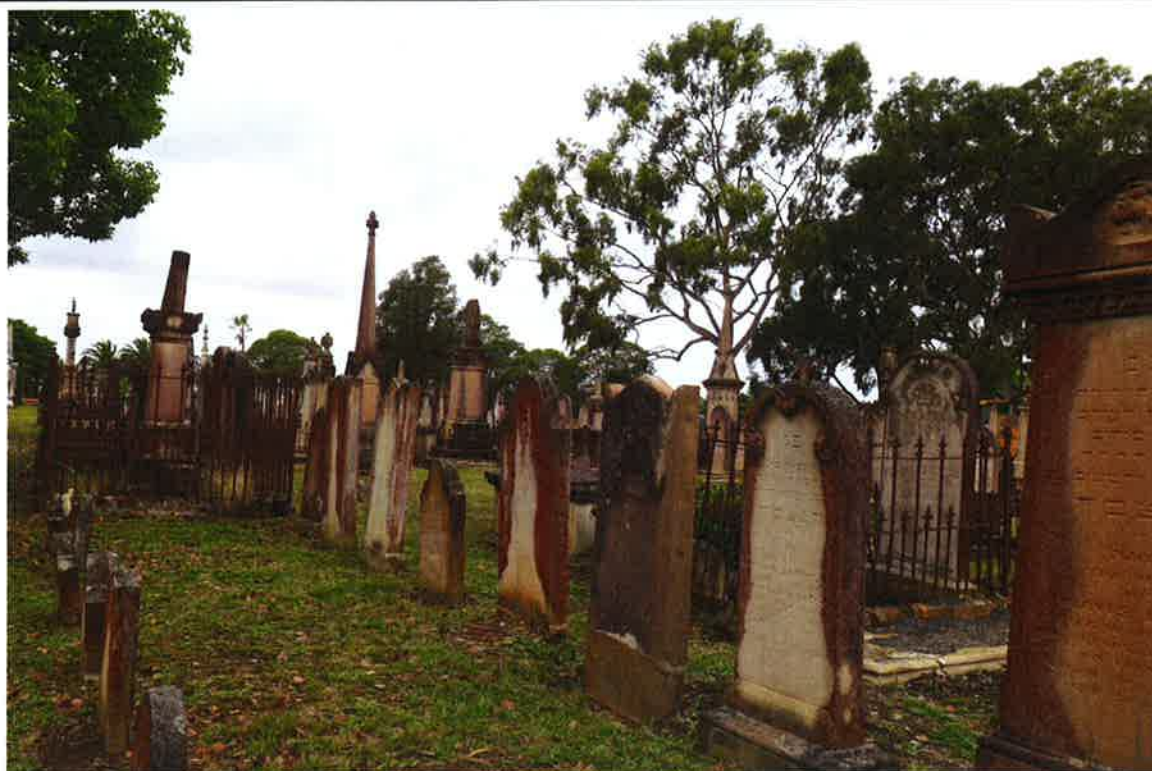
ITEM DETAILS—Jewish Old Ground

Name of Item	Jewish Old Ground			
Item Type	Cultural landscape			
Precinct	MU: 12; Zone: A			
Management Context	Within SHR			
Associated With	'Old Independent' section (to the S); Independent Office; Jewish Martyrs Memorial (to the W)			
Physical Description	A range of high quality monuments including some of exceptional significance, with graves oriented north-south, in a ridgeline landscape with remnant avenue plantings including Canary palms and Eucalypts. This section was originally laid out with sets of two graves with north-south pathways in addition to the surviving rows. Remaining trees, brick kerbs and edging and a grassed over central route (no longer in vehicular use) remain as strong evidence of the original cemetery layout. The southern half of the area contains a number of monuments and memorials relocated from the Devonshire Street cemetery. An original identification marker (a fluted iron post with a small identifying plate at the top) can be found near Necropolis circuit.

Conservation Priority Actions	<ul style="list-style-type: none"> Repair damaged kerb sets and railings on a planned basis; Reinstate original road edging details, drainage and path layout as needed; Prioritise significant tree assessment and planting restoration options. 						
Asset Management Requirements	Do		Don't				
	<ul style="list-style-type: none"> Remove and control vegetation that may obscure or damage headstones, graves or monuments to preserve landscape integrity Monitor condition and establish repair priorities on a cyclical basis. Ensure any new damage or breakage is addressed immediately on detection Undertake necessary first-aid repairs to collapsed graves, damaged kerbs, railings and other monuments according to conservation principles, without damaging significance. Maintain grass paths between graves/plots for pedestrian access. Maintain the landscape character of the place by retaining and potentially restoring avenue plantings. Retain marker trees and mass plantings on the ridge. Maintain secondary and tertiary route alignments, including Paton St, free of burial Ensure infrastructure and traffic upgrades to primary roads (e.g. Necropolis Ave) take into account the likely heritage impacts to the area. Strengthen visual connectivity to Units 7 and 13A (via the Old Independent Section) and explore opportunities for interpretation of Jewish and multicultural heritage at Rookwood 		<ul style="list-style-type: none"> Replace, relocate or remove memorials, parts of memorials or original markers without first assessing significance. Undertake planting restorations without first seeking advice from the JCRT. Allow new monuments within the Old Ground. Permit new excavation or development without considering the heritage impact on the memorial landscape, its intact circulation patterns and layout Attempt or allow cleaning, painting or restoration of headstones or inscriptions without heritage advice. Permit new paving, road alterations, facilities, signage or landscaping that may detract from heritage significance of the place and its immediate surroundings.

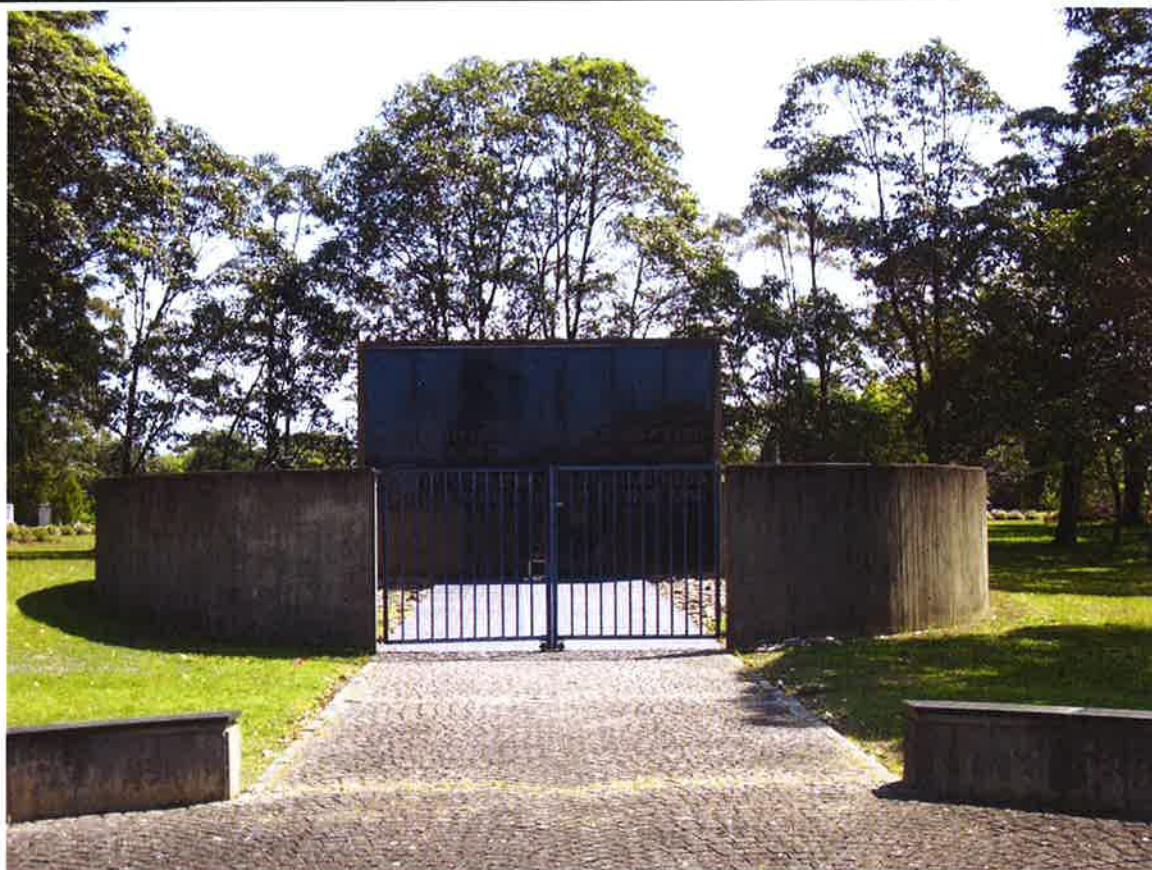
ITEM DETAILS—Martyrs Memorial

Name of Item	Memorial to the Martyrs of Jewish Persecutions			
Item Type	Monument			
Precinct	MU: 7 (Necropolis Circuit)			
Management Context	Within SHR			
Associated With	Necropolis Circuit; Jewish Old Ground			
Physical Description	The monument consists of an enclosed egg-shaped cell, the egg being regarded as a symbol of resurrection and immortality, inside which is a granite inscription fixed to a tall free-standing vertical slab of concrete, reading "In memory of six million Jews killed by the Nazis during the War 1939-1945. May the world never again witness such inhumanity of man against man". The curved walls are in board marked concrete, inscribed with the names of the most infamous concentration camps of the Second World War. Trachyte setts echo traditional European street paving, forming a ceremonial path (subsequently overlaid with imitation paving in some areas) from the reception space to the inscription panel via a pair of simple bronze gates.

Condition	Excellent <input type="checkbox"/>	Good <input type="checkbox"/>	Fair <input checked="" type="checkbox"/>	Attention Required <input checked="" type="checkbox"/>
Conservation Priority Actions				
Asset Management Requirements	Do <ul style="list-style-type: none"> Remove any vegetation which may obscure or damage headstones, graves or monuments. Monitor memorials condition and establish repair priorities on a cyclical basis. Undertake necessary first-aid repairs to collapsed graves, damaged kerbs, railings and other monuments according to conservation principles, without damaging significance. Maintain grass paths between graves/plots for pedestrian access. Maintain the landscape character of the place. Maintain secondary and tertiary route alignments free of burial. Ensure infrastructure and traffic upgrades to primary roads (e.g. Necropolis Ave) take into account the likely heritage impacts to the area Keep stormwater drains clear and free of leaves and earth. Reinstate original brick kerbs on the original line where possible with original or matching materials. 		Don't <ul style="list-style-type: none"> Replace, relocate or remove memorials, parts of memorials, original markers without first assessing significance. Allow infill burial on paths or verges where this conflicts with general landscape character Remove, relocate, conceal, damage or modify existing circulation paths including heritage brick edges, kerbs and gutters Allow new monuments within the section except where approved under specific memorial guidelines for the area. Allow mechanical excavation and vehicular access to road verges and paths. Permit new excavation or development without considering the heritage impact on the memorial landscape and its values, as well as the section's potential historical archaeological relics. Attempt or allow cleaning, painting or restoration of headstones or inscriptions without heritage advice. Permit new paving, road alterations, facilities, signage or landscaping that may detract from heritage significance of the place and its immediate surroundings. Plant trees, shrubs or flora that are not in keeping with the original landscape character. Reclaim tertiary roads for burial or other development.

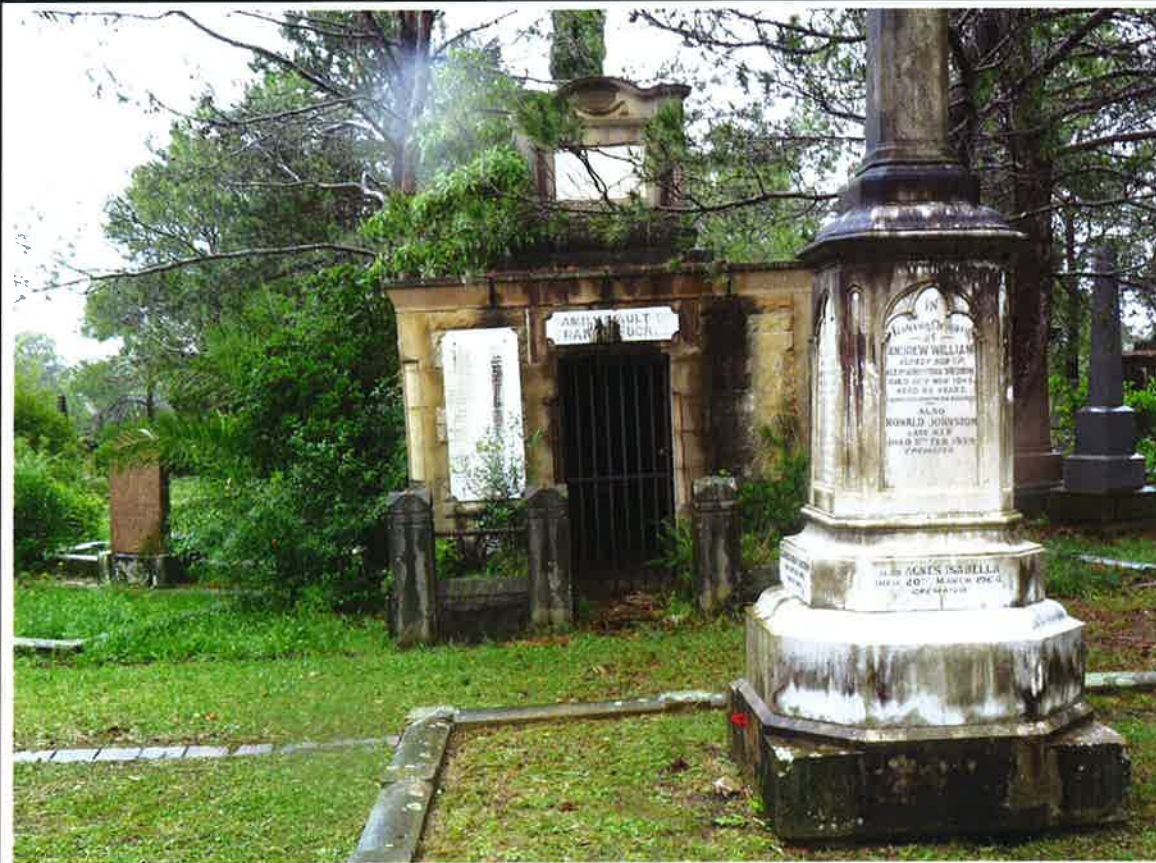
ITEM DETAILS—Presbyterian No.2 Section

Name of Item	Presbyterian No.2 or 'new' Presbyterian Section (part)				
Item Type	Cultural landscape				
Precinct	MU: 10, Zone: A				
Management Context	Non SHR				
Associated With	Old Presbyterian Section				
Physical Description	The New Presbyterian section is located south of Oliver Avenue. Roughly one quarter (0.75 ha) of it is laid out in a pattern of circular plots with a setting of mature plantings similar to the earlier Presbyterian Section.				
Historical Background	The New Presbyterian Section lies within the original 200 acres. Part of the northern sector of the Unit contains a number of exceptionally significant vaults and mausolea, including the John Dunmore Lang (dating from the 1870s) and the John Paul vault (1918). In 1879 the government acquired a further 577 acres to the east and south of the original site, although they were not officially gazetted until February 1889. This allowed expansion of the Presbyterian section still further.

Context of Significance	National <input type="checkbox"/>	State <input checked="" type="checkbox"/>	Local <input type="checkbox"/>	N/A <input type="checkbox"/>	
Condition	Excellent <input type="checkbox"/>	Good <input checked="" type="checkbox"/>	Fair <input type="checkbox"/>	Attention Required <input type="checkbox"/>	
Conservation Priority Actions	<ul style="list-style-type: none"> Repair and conserve vaults and monuments on a planned basis. 				
Asset Management Requirements	Do <ul style="list-style-type: none"> Remove or cut back any vegetation which is causing damage to headstones, graves or monuments, subject to significant tree study and as approved as Site Specific Exemptions. Monitor condition and establish repair priorities to memorials and vaults on a cyclical basis. Ensure any new damage, safety hazard or breakage is notified promptly on detection. Undertake necessary first-aid repairs to collapsed graves, damaged kerbs, railings and other monuments according to conservation principles. Maintain existing gravel paths, including all brick edgings and guttering, to tertiary paths and between graves/plots. Establish repair priorities and program for major vaults and mausolea. Ensure any new damage or breakage is addressed immediately on detection. Undertake necessary first-aid repairs to collapsed graves, damaged kerbs, railings and other monumentation according to conservation principles, without damaging significance. Maintain and restore the existing road/path hierarchy and layout. Reinstate the circular subdivisions defined by brick edging and guttering. Maintain the landscape character of the place by retaining and potentially restoring areas of original plantings. 		Don't <ul style="list-style-type: none"> Allow intensification or renewable interment. Allow new monuments within the section except where approved under specific memorial guidelines for the area approved by the NSW Heritage Council. Allow mechanical excavation and vehicular access to road verges grassed drives and paths. Permit new excavation or development without considering the heritage impact on the memorial landscape and its values, as well as potential historical archaeological relics. Attempt or allow cleaning, painting or restoration of headstones or inscriptions without heritage advice. Permit new paving, road alterations, facilities, signage or landscaping that may detract from heritage significance of the place and its immediate surroundings. Plant trees, shrubs or flora that are not in keeping with the original landscape character. Reclaim tertiary roads for burial.

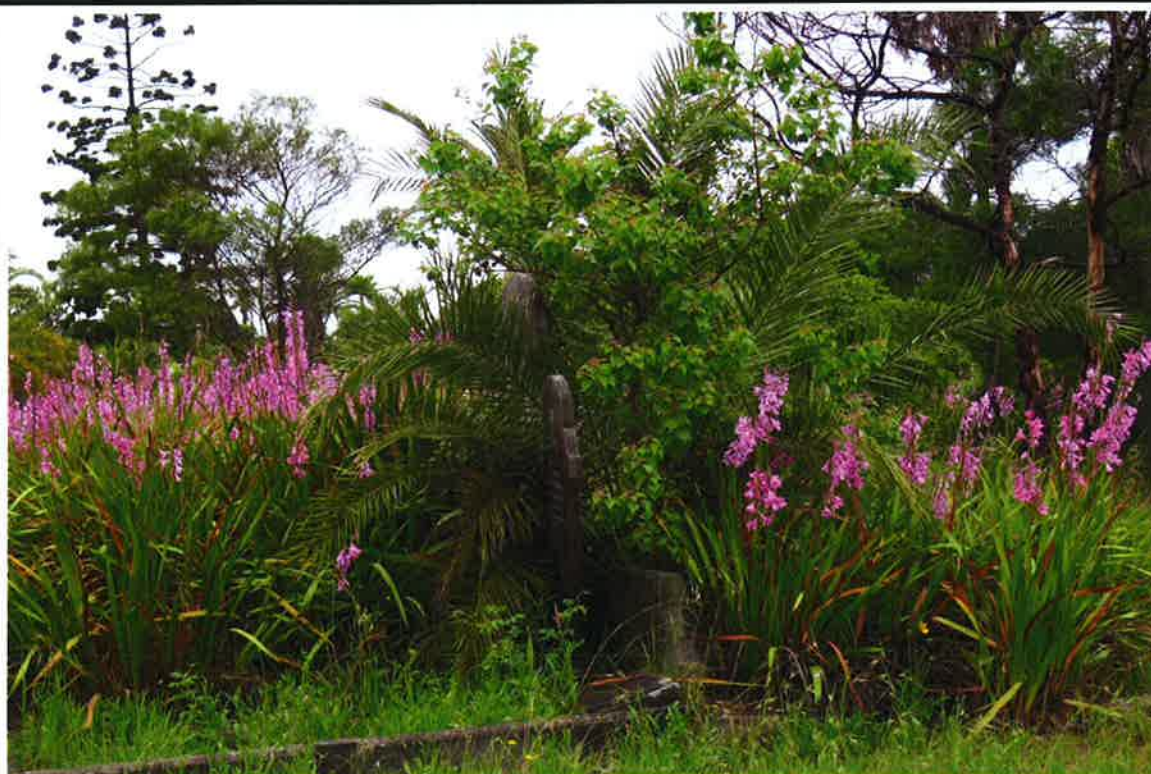
ITEM DETAILS—Anglican Extensions

Name of Item	Anglican Extension			
Item Type	Cultural Landscape			
Precinct	MU:4 Zone: C			
Management Context	Non SHR (RGCRT)			
Associated With	Anglican Shelters; Grave Digger's Hut			
Physical Description	The area consists of an extension to the Anglican No.1 layout with a corresponding rectilinear grid plan of intersecting paths and nodes. Nodes feature important landmark trees and shelters providing visual accents. Landmark vegetation in the form of Hoop, Bunya and Norfolk pines creates long axial views complementing the grid and dipping topography which falls towards the Little Canal, an important piece of working historic infrastructure.			
Historical Background	In 1879 the government acquired a further 577 acres to the east and south of the original site, although they were not officially gazetted until February 1889. The Anglican Trust acquired 190 acres just east of its existing cemetery, the western part of this extension area being laid out by first JH Maiden from 1889 to 1895. The trustees built a second drain through their extension (the Little Canal) and burial plots gradually extended beyond the canal as far as a projected railway easement for the proposed extension to the railway (intended to loop diagonally across the new Anglican area to Lidcombe (shown on an 1891 plan but never built). Rest shelters were constructed in the 1920s as the western part of the cemetery came into use following the completion of the railway to Mortuary Station 4.

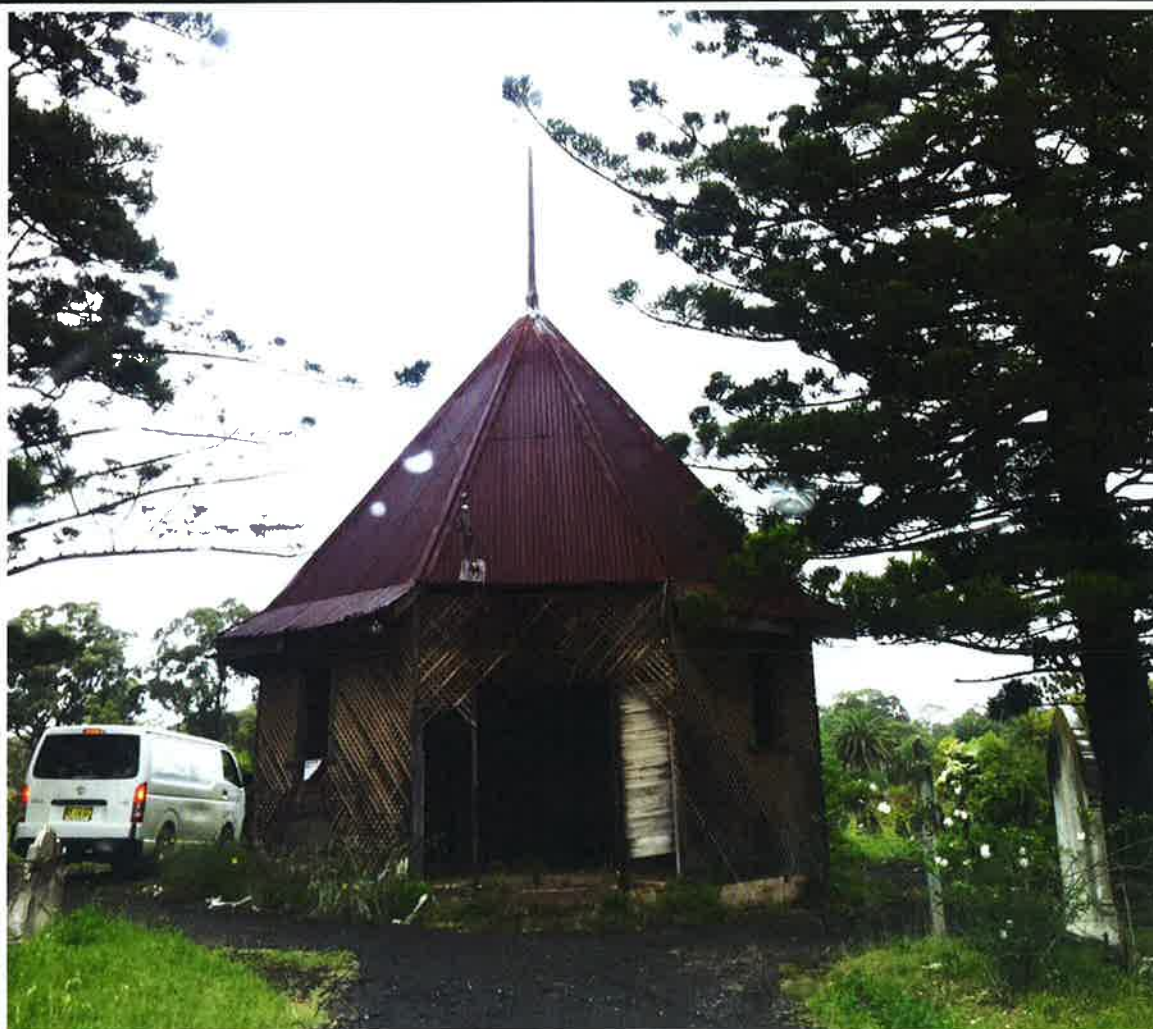
Name of Item	Old Grave Digger's Hut			
Item Type	Building			
Precinct	MU:6, Zone: C			
Management Context	Non SHR			
Associated With	Anglican brick shelters; Terminus and All Souls Precinct; Anglican Extensions			
Physical Description	<p>The Old Grave Digger's Hut sits at the intersection of two tree-lined avenues in the 'New' Anglican section with the three brick shelters nearby.</p> <p>The structure is an octagonal timber shelter with a steep pyramid roof formed by intersecting scissor rafters, topped with a tall timber finial and covered with corrugated iron sheeting. The walls are timber framed with timber lattice and weatherboard lining. The early fittings and fixtures remain but are in a poor state. The floor was originally brick pavers with many now missing. The structure is flanked by mature pine trees, accentuating its location and connection with the landscape around it.</p>			
Historical Background	The hut is believed to have been constructed in the early 1900s and the design has been attributed to John Bursham Clamp. It was a shelter and rest house for grave diggers and potentially hearse drivers

Asset Management Requirements	Do		Don't				
	<ul style="list-style-type: none"> Maintain the distinctive character of the building and its setting. Cut back any vegetation that poses a risk of damage to the building fabric. Ensure appropriate storm drainage at ground level. Enable equitable access by sympathetic means. Conserve the decorative design and form of the shelters. Use like for like materials during essential roofing, cladding and rainwater repairs. Monitor the condition through regular inspection and keep secure, clean and weathertight and free of rubbish. Follow NSW Minimum Standards of Repair for SHR items (although the item is outside the SHR) to ensure adequate weather protection and security, with the advice of a heritage consultant as required. Ensure that any changes or addition of materials for maintenance or security measures are approved, easily reversible and can be identified on close inspection. Make safe from vandalism and fire without destroying the building fabric; control damage by birds and vermin where reasonably practicable without impacting on significance. Reinstate the landscape setting and reduce risks to fabric by undertaking appropriate tree maintenance without harming significant planting patterns and features. Explore a range of low-impact options for re-use in consultation with a heritage consultant. Restore physical connections to nearby shelters and All Souls Precinct, e.g. as part of a self-guided walk in the C.H. Maiden Anglican Section. 		<ul style="list-style-type: none"> Replace, demolish or remove fabric without first understanding potential impact on the heritage values. Remove elements of heritage value unless this is essential for safety, structural or operational reasons, and only on advice from qualified heritage specialists. Replace original fabric with unsympathetic modern materials. Attempt cleaning, emergency repair or restoration of without seeking advice from qualified heritage specialists on appropriate methods. Make alterations to interior/ exterior appearance, fixtures or structure without heritage advice. Allow any fire prevention upgrades that are unsympathetic to its heritage values and informal character.

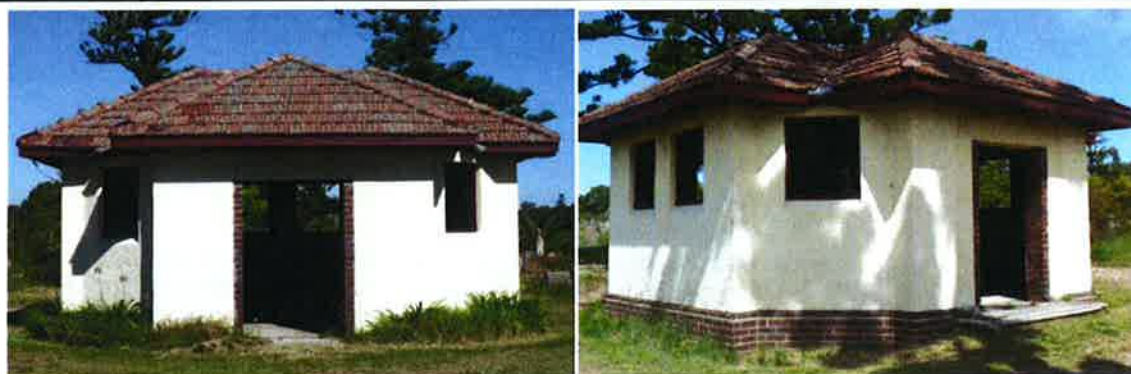
Name of Item	Anglican Brick Shelters				
Item Type	Building Group (3)				
Precinct	MU:4, Zone C				
Management Context	Non SHR				
Associated With	Old Gravedigger's Hut				
Physical Description	<p>The three shelters are positioned at nodes along an east-west axis through the cemetery with an alignment on a north-south axis with the earlier timber shelter known as the Grave Digger's Hut. The eastern and western buildings are identical in construction aside from the orientation of the entrance. They are eight sided, cruciform in plan, with red brick dressings to doorways and cavity brick walls. External walls are cream roughcast render above a brick plinth with a Marseille pattern terracotta tiled roof. The floors are terrazzo concrete with coarse aggregate. Internal walls are exposed brick. Timber seating and ceiling and original lattice infill panels on the 10 windows have been removed.</p> <p>The middle shelter (no.2) is an eight-sided masonry structure, cavity brick with a cruciform plan and entrance on the northern side with concrete Doric style columns. The external walls are face brickwork with a low brick plinth. The roof is covered with grey corrugated steel sheeting and the internal ceilings have been removed. The internal walls are exposed brick and the floor is a terrazzo concrete with coarse aggregate. Lattice window panels have been removed.</p>

<p>Requirements</p>	<ul style="list-style-type: none"> • Maintain the distinctive character of the buildings and their setting. • Cut back any vegetation that poses a risk of damage to the building fabric. • Monitor the condition through regular inspection and keep secure, clean and weathertight and free of rubbish. • Use like for like materials during essential roofing, cladding and rainwater repairs. • Follow NSW Minimum Standards of Repair for SHR items (although the item is outside the SHR) to ensure adequate weather protection and security, with the advice of a heritage consultant as required. • Ensure that any changes or addition of materials for maintenance or security measures are approved, easily reversible and can be identified on close inspection. • Make safe from vandalism and fire without destroying the building fabric; control damage by birds and vermin where reasonably practicable without impacting on significance. • Reinstate the landscape setting and reduce risks to fabric by undertaking appropriate tree maintenance without harming significant planting patterns and features. 	<ul style="list-style-type: none"> • Replace, demolish or remove fabric without first understanding potential impact on the heritage values. • Remove elements of heritage value unless this is essential for safety, structural or operational reasons, and only on advice from qualified heritage specialists. • Replace original fabric with unsympathetic modern materials. • Attempt cleaning, emergency repair or restoration of without seeking advice from qualified heritage specialists on appropriate methods. • Make alterations to interior/ exterior appearance, fixtures or structure without heritage advice. • Allow any fire prevention upgrades that are unsympathetic to its heritage values

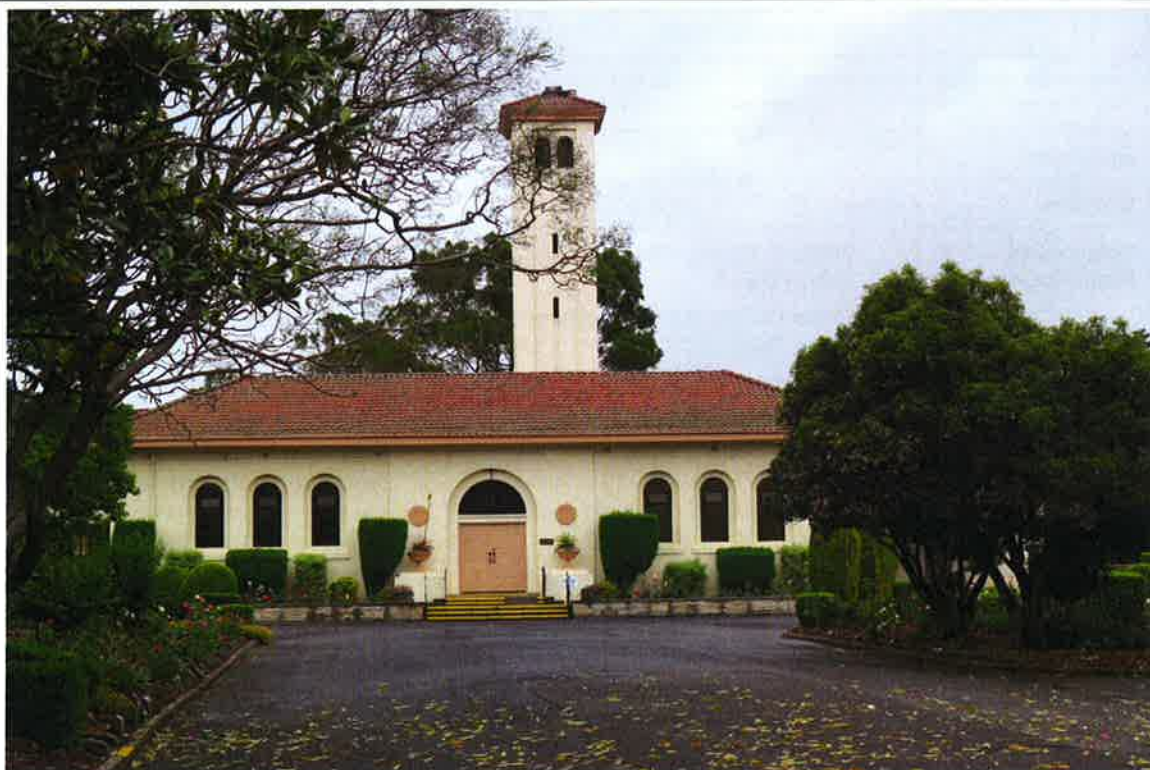
ITEM DETAILS—Crematorium

Name of Item	Crematorium and Chapels			
Item Type	Building			
Precinct	MU:15, Zone J			
Management Context	On Crown Land Reserve (unallocated). Managed and leased from RNT by Invocare until 2025. Listed on the AIA Register of Significant 20th century Architecture in NSW			
Associated With	Crematorium Residence and Walled Garden			
Physical Description	<p>The crematorium, built in the inter-war Mediterranean style of architecture is a white cement-rendered building with arcaded loggias and colonnades, steel windows and a Tuscan-influenced tower which disguises the chimney from the crematorium ovens. It is decorated with Art Deco statues and classical iron work. It has beige marble floors with green marble bordering. The roof of the building and tower are covered with terracotta tiles.</p> <p>The original design features one chapel along with the crematorium but has since been expanded to include offices and three chapels along with the crematorium ovens. These later constructions are all sympathetically designed to the original building. The crematorium and chapels sits within a Walled Garden of Remembrance.</p>

Asset Management Requirements	Do		Don't				
	<ul style="list-style-type: none"> Maintain evergreen planting in front of the building in keeping with the clipped classical style Maintain the setting and curtilage of the crematorium Maintain the layout, form and massing of the building and do not allow extensions or additions that may adversely affect heritage values 		<ul style="list-style-type: none"> Damage any fabric on the internal or exterior of the crematorium and chapel Allow use of the building which may damage or alter the crematorium and chapel and associated landscape Attempt cleaning or restoration of the concrete rendering, steel framed windows or terracotta roofing without heritage advice Permit new paving, road alterations, facilities, signage or landscaping that may detract from heritage significance of the place and its immediate surroundings Plant trees, shrubs or flora that are not in keeping with the original landscape character. Allow or major or minor incremental development that will impact on views to and from the building and setback of the principal façades Allow additional signage to be fixed to the facade

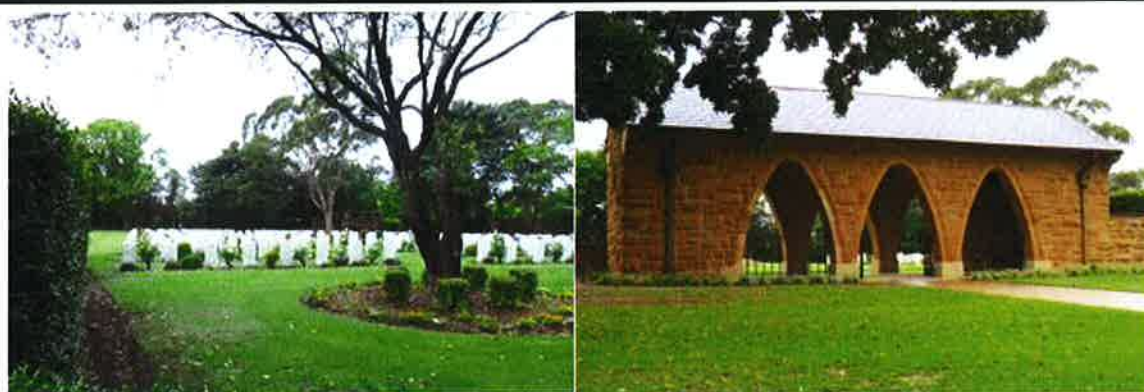
ITEM DETAILS—Sydney War Cemetery and Loggia

Name of Item	Sydney War Cemetery and Loggia				
Item Type	Cultural Landscape				
Precinct	MU: 21, Zone: H				
Management Context	Maintained strictly to Commonwealth War Graves standards by the Office of Australian War Graves (OAWG). Leased to the Commonwealth War Graves Commission by the RGCRT				
Associated With					
Physical Description	The Sydney War Cemetery is Australia's largest war cemetery and the only Australian war cemetery that has a Stone of Remembrance. The War Cemetery consists of lawn burials with identical white marble stelae with rose gardens at the foot of the headstone. Hedging and walls define the different areas within the one memorial landscape and insulate the cemetery from the rest of Rookwood. The Loggia is a sandstone clad rectangular structure with three parabolic arches on the long sides, a slate roof, copper gutters and downpipes and wrought iron gates and railings. Small steel-framed elliptical windows are in each of the gabled ends. The ceiling is composed of timber boards with a stained finish and the floor is sandstone flagging. The northern end of the building contains the NSW Cremation Memorial and the southern end, a lectern with a register of the burials

Condition	Excellent <input checked="" type="checkbox"/>	Good <input type="checkbox"/>	Fair <input type="checkbox"/>	Attention Required <input type="checkbox"/>
Conservation Priority Actions				
Asset Management Requirements	Do <ul style="list-style-type: none"> • Manage the area in accordance with Commonwealth War Graves Commission recommendations. • Official headstones and plaques are the property of the Office of Australian War Graves. • Refer any condition or repair issues concerning graves or buildings to the OAWG. • Maintain the geometric and formal character of the area, and perimeter buffer planting. • Maintain axial views into the area and hedging layouts to define spaces. • Maintain the nearly clipped lawn setback. 		Don't <ul style="list-style-type: none"> • Alter war cemetery graves or monuments without approval from the OAWG. • Damage headstones, plaques etc. with gardening or grounds maintenance equipment. • Allow parking on road verges and grassed drives in front of the cemetery. • Permit new burials without approval from the Office of Australian War Graves. • Attempt or allow cleaning, painting or restoration of buildings, gates, headstones or inscriptions without heritage advice. • Permit new paving, road alterations, services, facilities, signage or landscaping that may detract from heritage significance of the place and its immediate surroundings. • Plant trees, shrubs or flora in the management unit that are not in keeping with the original.

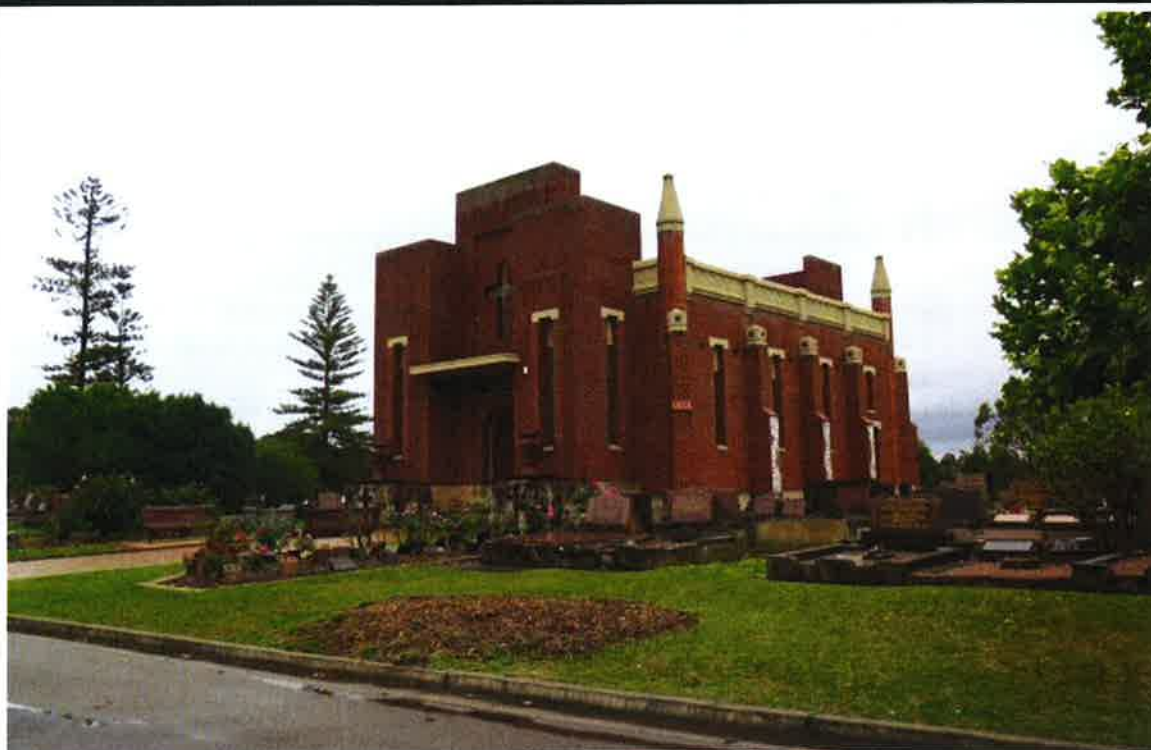
ITEM DETAILS—All Souls Precinct

Name of Item	All Souls Precinct		
Item Type	Cultural Landscape (with buildings)		
Precinct	MU: 4&5, Zone C&D		
Management Context	Non SHR (RGCRT)		
Contains	High Significance All Souls Chapel US War Cemetery and shelter (See separate sheet)	Moderate Significance Anglican Office Merchant Navy Columbarium and wall	
Physical Description	<p>The precinct is a termination point for the railway loop. It is a mixed landscape dating from c.1943-55, including a number of key buildings or remains of high significance that together with a number of landmarks and landscape elements form an important group in the north eastern part of Rookwood. There are also buildings of moderate significance, altered in form but still contributing substantially to the relationships of built and landscape forms within the precinct. The Anglican Office (built 1935) is an example of Inter War Georgian revival architecture. The Merchant Navy wall is built of rock-faced sandstone in 190mm courses. It features smooth sawn stone blocks forming commemorative piers at the entry, with enamelled bronze lettering.</p> <p>The area lacks cohesion in terms of burial areas, but has potential as a hub for visitation and interpretation, notably with good visual and physical connections to the Anglican shelters group in Unit 4. The area also has a high concentration of war graves managed by OAWG. Timber Lattice Shelter No.3 is a recent reconstruction (c.2002) designed to complement the earlier shelters of the Old Anglican Section. It has an approach confined between modern intrusive brick walls.</p>

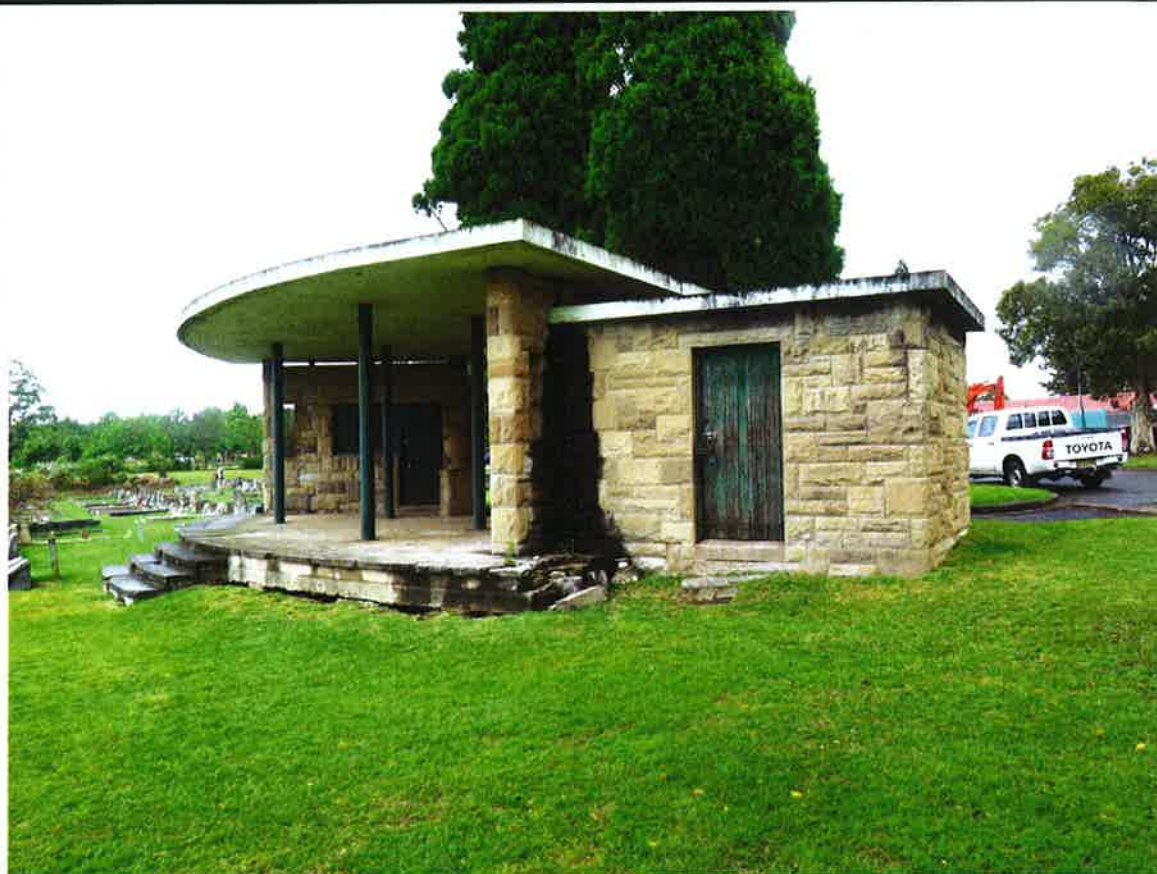
ITEM DETAILS—US War Cemetery and Shelter

Name of Item	US War Cemetery and Shelter			
Item Type	Cultural Landscape			
Precinct	MU: 5, Zone: D			
Management Context	Non SHR, RGCRT			
Associated With				
Physical Description	The US war cemetery was originally laid out as a walled, rectangular parterre of around 0.5 ha with flagstaff in the centre. Parts of the cemetery have been re-used for interment since most of the remains were repatriated. The main landmark is the cemetery shelter, built in c. 1950 from rock-faced sandstone blocks. It has steel and timber joinery, internal brick lining to storage rooms, and a flat reinforced concrete slab roof supported on four cylindrical steel columns. The building stands at the end of the railway line, where the buffers would have been situated.			
Historical Background	The US cemetery was laid out in December 1942 with space for 800 graves, and contained the remains of almost 500 servicemen by 1945, including some from Karakatta Cemetery, Perth, WA, and from overseas. The vast majority were repatriated in 1947. There are also a number of memorials to American Civil War veterans. Some modifications have been made to the steps.

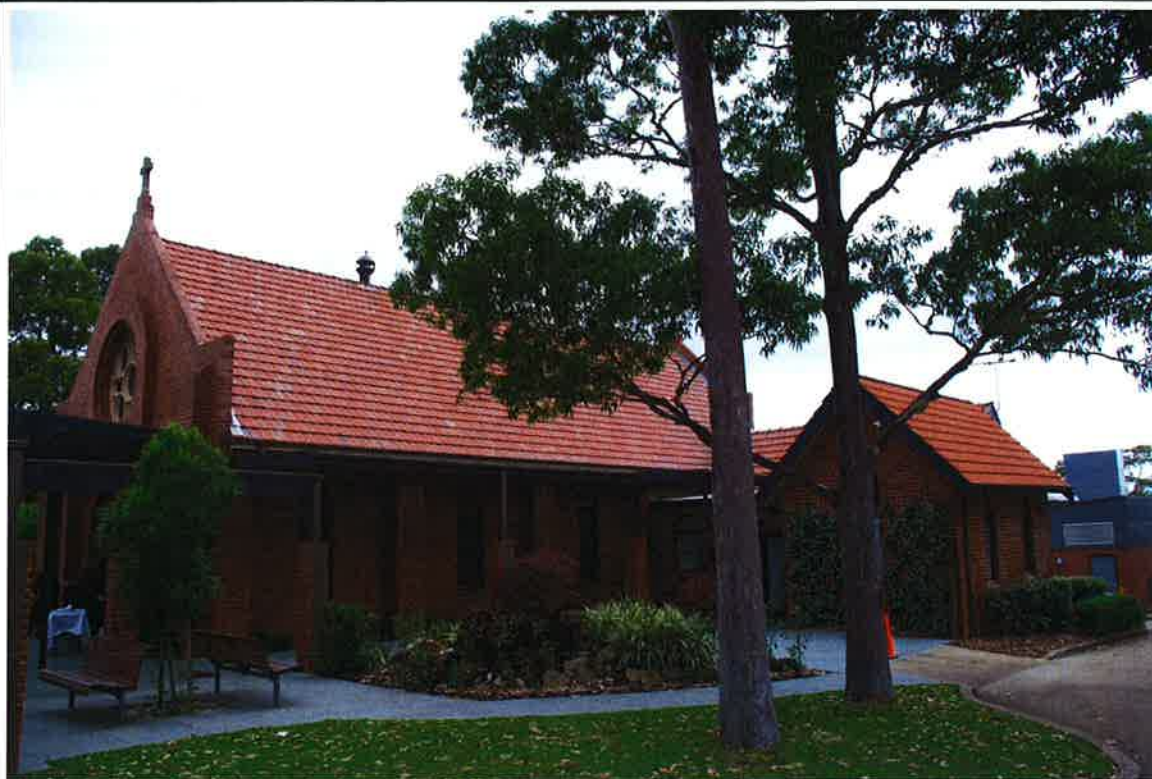
ITEM DETAILS—Sacred Heart Chapel

Name of Item	Sacred Heart Chapel				
Item Type	Building				
Precinct	MU: 17, Zone: CMCT				
Management Context	Non SHR, CMCT				
Associated With					
Physical Description	Gable-ended brick chapel with steeply pitched roof clad in terracotta tiles. Features simple geometric leadlight windows including large ornamental leadlight glass wheel windows in both gable end walls. Later extensions at south western corner. It has face brickwork internally as well as externally, leadlight windows with arched heads in the side walls and Marseilles pattern clay roof tiles. The ceiling is timber boarding with stained finish above exposed timber and metal roof trusses.				
Historical Background	The Chapel was built in 1928 and refurbished in 1994 and 2011.				
Heritage Significance	Historic <input checked="" type="checkbox"/>	Historical Association <input type="checkbox"/>	Aesthetic <input checked="" type="checkbox"/>	Social <input checked="" type="checkbox"/>

Technical/Research <input type="checkbox"/>	Representativeness <input type="checkbox"/>	Rarity <input type="checkbox"/>	Integrity <input type="checkbox"/>	
	The Sacred Heart Chapel is Significant because: <ul style="list-style-type: none"> It is a well preserved, representative example of the kind of chapel provided for mourners during the late phase of historic development of Rookwood 				
Level of Significance	Exceptional <input type="checkbox"/>	High <input checked="" type="checkbox"/>	Moderate <input type="checkbox"/>	Little <input type="checkbox"/>	None <input type="checkbox"/>
Context of Significance	National <input type="checkbox"/>	State <input type="checkbox"/>	Local <input checked="" type="checkbox"/>	N/A <input type="checkbox"/>	
Condition	Excellent <input type="checkbox"/>	Good <input checked="" type="checkbox"/>	Fair <input type="checkbox"/>	Attention Required <input type="checkbox"/>

Asset Management Requirements	Do	Don't
	<ul style="list-style-type: none"> Remove any vegetation which may obscure of damage the walls of the chapel Monitor conditions and establish repair priorities on a cyclical basis Ensure any new damage or breakage is addressed immediately Maintain the landscape character of the place Remove intrusive elements from the exterior on heritage advice to enhance significance 	<ul style="list-style-type: none"> Replace, relocate or remove any part of the chapel without first assessing significance Damage any fabric on the internal or exterior of the chapel. Allow use of the building which may damage or alter the chapel and associated landscape. Attempt cleaning or restoration of the masonry, slate roof, stained-glass, interior flooring and finishes, or movable items without heritage advice. Permit new paving, road alterations, facilities, signage or landscaping that may detract from heritage significance of the place and its immediate surroundings. <p>Plant trees, shrubs or flora that are not in keeping with the original landscape character.</p>

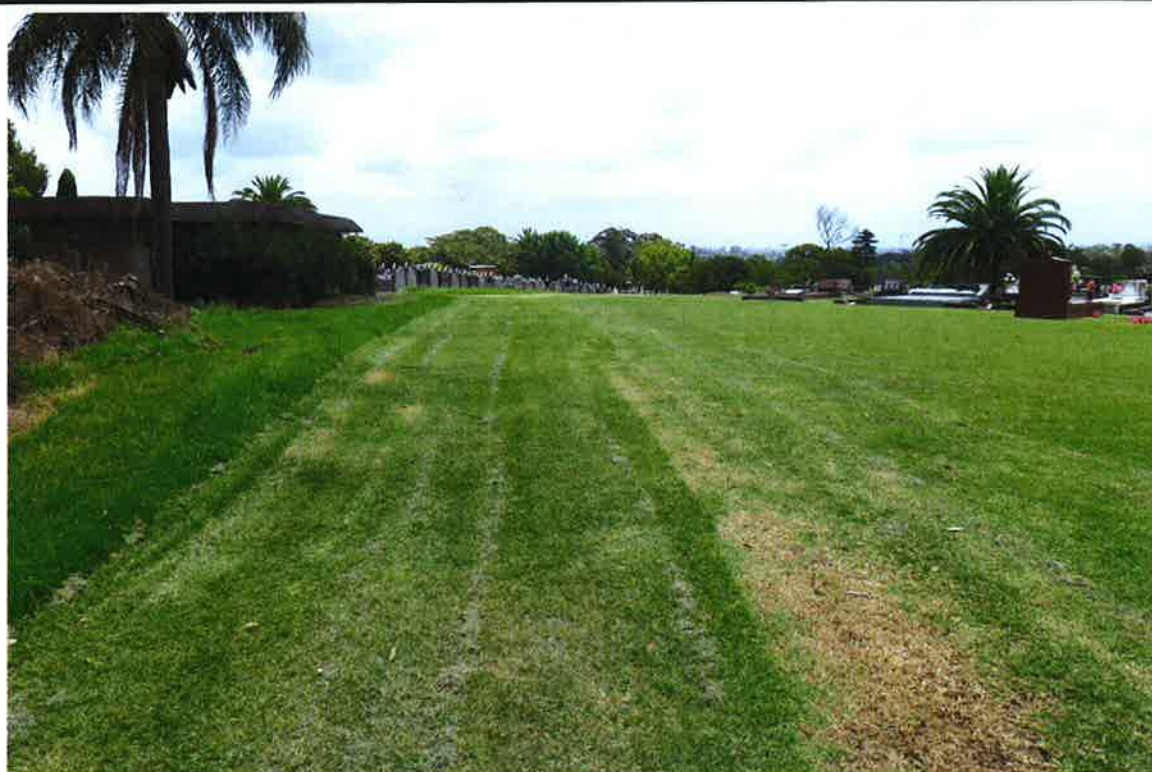
ITEM DETAILS—Railway Loop

Name of Item	Railway Loop			
Item Type	Cultural Landscape (historic infrastructure)			
Precinct	Various			
Management Context	SHR and non SHR			
Associated With	Old Catholic Section, Necropolis Circuit & Mortuary Station No.1; Old Chinese Section; All Souls Precinct			
Physical Description	<p>The railway loop forms the backbone of the original cemetery and was constructed to service the original sections via the four Mortuary Station stops (the last of which, Mortuary Station No.4, was completed in 1908. The railway corridor passes along salient ridgelines in the topography and is therefore intrinsic to the site's layout and geography, linking key vistas within and beyond the cemetery. It services destinations along the route that represent or contain highly significant built objects, zones or landscapes. The loop itself consists of a 16m wide corridor extending from the northern boundary of the Old Catholic cemetery (MU 2) to the railway sidings in the All Souls Precinct. Parts of the corridor have been developed for burial, roads or buildings. The most intact sections are located in Units 2 (which includes tracks concealed under the topsoil), 7, 8A, 13C, 17 and 5 (Railway Sidings). The Railway Loop includes a number of areas of archaeological sensitivity. Substantial sectors of the Loop have been infilled with graves in the 1980s and 1990s and it no longer forms a continuous easement.</p>
