9.0 Appendices

Heritage Asset Management Sheets

Rookwood Archaeological Assessment (AA)

GML Heritage

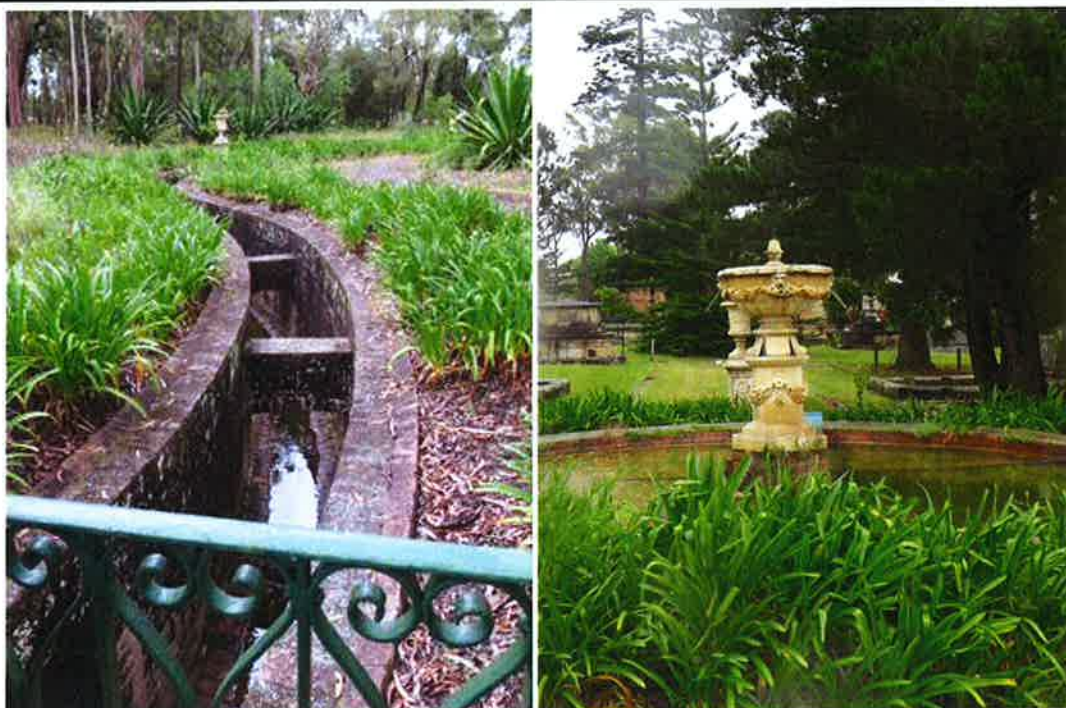
ITEM DETAILS—Serpentine Canal

Name of Item	Serpentine Canal			
Item Type	Cultural Landscape (historic infrastructure)			
Precinct	MU: 3, Zone: B			
Management Context	Within SHR; managed by RNT as common infrastructure			
Associated With	Anglican Lattice Shelters; Old Anglican Section			
Physical Description	<p>The drainage system now known as the serpentine canal began as a brick drain 900mm wide and 1700mm deep with three shallow circular ponds along its length with accompanying fountains, urns and statues.</p> <p>The decorative elements, in particular the urns, have been replaced with replicas along the lengths of the canal as well as at some of the ponds (some of the originals have been salvaged and stored in the stonemasons' yard).</p>			
Historical Background	<p>The Serpentine Canal was designed largely by Simeon Pearce and constructed from 1874 alongside the landscaping of the Anglican area from William drive to the Serpentine canal. Initially seen as a solution for drainage issues as the cemetery expanded, the construction of the canal also provided further opportunities to increase the beautification of the cemetery, with the inclusion of decorative urns and fountains placed along the route and ponds planted with decorative lilies and other water plants. Between 1889 and 1895 the trustees built a second drain further east within the Anglican cemetery. By 1899 the fountains connected to the serpentine were connected to water and put in use on Sundays.</p>

character, form and vegetation for funerary landscapes. <ul style="list-style-type: none"> Demonstrates nineteenth-century attitudes towards public health and water management in burial grounds 				
Level of Significance	Exceptional <input checked="" type="checkbox"/>	High <input type="checkbox"/>	Moderate <input type="checkbox"/>	Little <input type="checkbox"/>	None <input type="checkbox"/>
Context of Significance	National <input type="checkbox"/>	State <input checked="" type="checkbox"/>	Local <input checked="" type="checkbox"/>	N/A <input type="checkbox"/>	
Condition	Excellent <input type="checkbox"/>	Good <input checked="" type="checkbox"/>	Fair <input type="checkbox"/>	Attention Required <input type="checkbox"/>	
Conservation Priority Actions	<ul style="list-style-type: none"> Develop a Conservation Management strategy for all the canal systems at Rookwood 				
Asset Management Requirements	Do <ul style="list-style-type: none"> Control vegetation and manage public access in the interest of safety, but ensuring the brick channels can be seen and appreciated from the path Encourage public enjoyment of the canal by ensuring appropriate wayfinding signage is displayed Replace any damaged elements with the same fabric or, at least, match the existing as closely as possible. Ensure that replacement fabric necessary for repair can be identified as replacement on close inspection. Ensure that any changes or addition of materials for maintenance or security measures are easily reversible. Inspect the canal and ponds on a cyclical basis Regularly clear plants and sediment build-up from canals to maintain water flow Maintain records of maintenance works for entire length of canal and related features- ie ponds or fountains. 		Don't <ul style="list-style-type: none"> Alter the profile or brickwork details in any portion of the canal. Allow existing plantings or new vegetation schemes to obscure the canal or the viewpoints along its length Remove or relocate associated features i.e., statues or other movables Remove elements of heritage value unless this is essential for safety, structural or operational reasons, and following advice from heritage specialists Allow any minor development (e.g. ground niches or plaques) near the canal to diminish its heritage significance or landscape value. Attempt clearing of vegetation or restoration of the canal without seeking advice for appropriate methods.

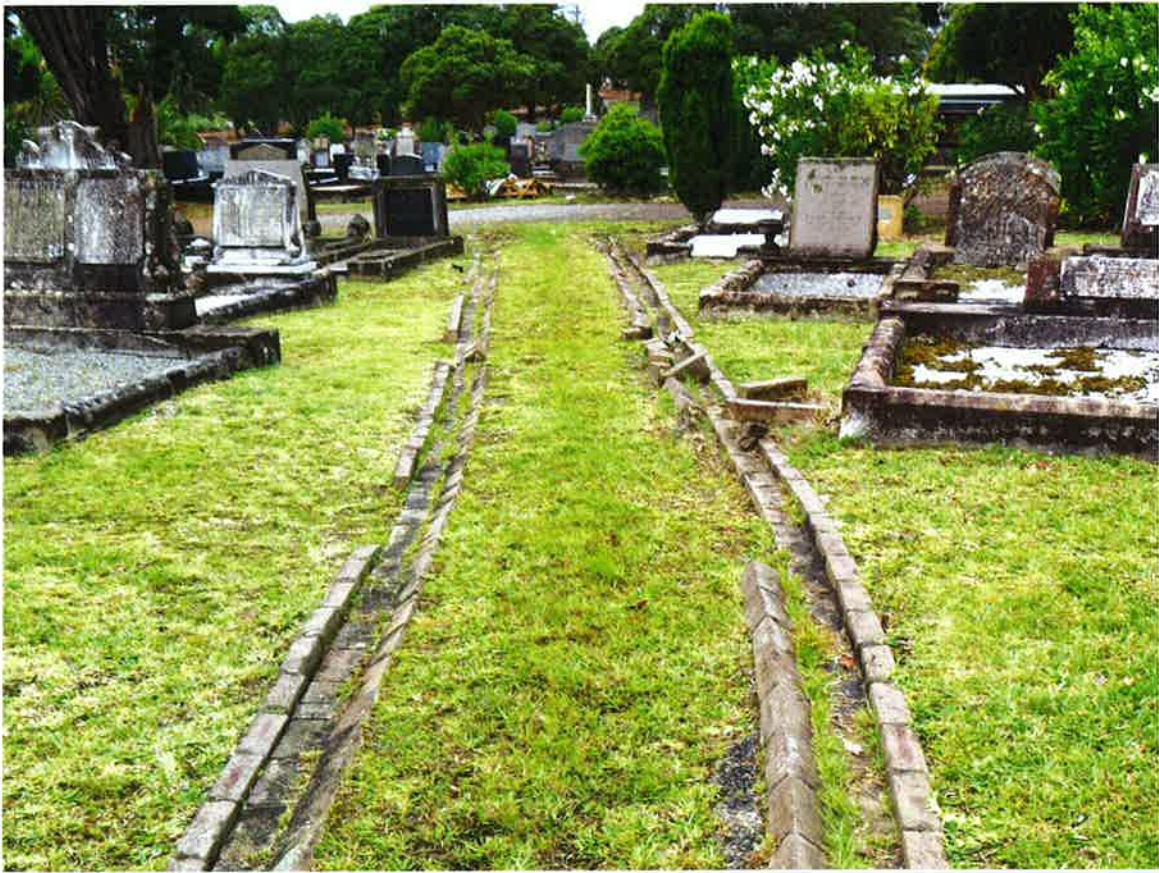
ITEM DETAILS—Secondary and Tertiary Road Network

Name of Item	Secondary and tertiary road network				
Item Type	Cultural Landscape				
Precinct	All Units laid out before 1943				
Management Context	Primary roads managed by RNT. Secondary and tertiary roads managed by individual trusts				
Associated With					
Physical Description	Tertiary roads (sealed and unsealed—as mapped in the Landscape Mater Plan) generally have low traffic volumes and vary in width from three lanes to one. Early tertiary roads define the layout of the original allocations of land and burial parcels and reveal evidence of the landscape planning concept which is a highly significant feature of Rookwood's heritage.				
Historical Background					
Heritage Significance	Historic <input type="checkbox"/>	Historical Association <input type="checkbox"/>	Aesthetic <input checked="" type="checkbox"/>	Social <input type="checkbox"/>	
	Technical/Research <input checked="" type="checkbox"/>	Representativeness <input type="checkbox"/>	Rarity <input type="checkbox"/>	Integrity <input checked="" type="checkbox"/>

Condition	Excellent <input type="checkbox"/>	Good <input type="checkbox"/>	Fair <input checked="" type="checkbox"/>	Attention Required <input type="checkbox"/>
Conservation Priority Actions	<ul style="list-style-type: none"> Establish a common road profile for tertiary roads that takes account of heritage values, and retains or restores existing brick guttering and details. Undertake necessary repairs to road surfaces and storm drainage to comply with section 9H of the NSW Heritage Office Minimum Standards for Maintenance and Repair. 			
Asset Management Requirements	Do <ul style="list-style-type: none"> Maintain grass verges unburied at least 1m from the gutter. Ensure original storm water pits are not damaged by vehicles or machinery, and drains are kept clear of weeds, leaves and debris and periodically checked to make sure they are working. Reinstate loose or disturbed original brick gutters and road edging using the original materials. When repairing road edging and guttering, match the method of laying and appearance of the original, using matching new materials for repair or restoration. Use salvaged bricks to make necessary minor repairs provided the salvaged material is matching in colour, size and type and provided other significant structures or fabric, including other road edgings and gutters, are not raised, damaged or dismantled. Retain and restore planted avenues on secondary and tertiary roads based on evidence and with arborists' advice, as indicated in LMP. Install sympathetic permanent vehicle barriers (fixed or movable) in areas where vehicle access is prohibited, in keeping with heritage values 		Don't <ul style="list-style-type: none"> Upgrade any tertiary roads within designated cultural landscape areas. Repair original brick gutters, road edging and storm water pits using bricks of different size, type or colour, or stone or concrete (unless originally stone or concrete). Guess at the location of early or missing or lost original road edgings, swales, gutters and other road and path details. Obtain heritage advice prior to reinstating sections of missing road detailing where original alignment is unclear. Excavate or disturb land, for the purpose of road repair or repair to road or path detailing, in the vicinity of relics (except in accordance with standard exemptions). Excavate or disturb land, for the purpose of repairs to utilities or storm water disposal systems, in the vicinity of relics (except in accordance with standard exemptions). Reclaim or build over tertiary roads in any SHR areas or any non SHR areas of exceptional or high significance. Use inappropriate modern road surfacing profiles in significant cultural landscape areas.

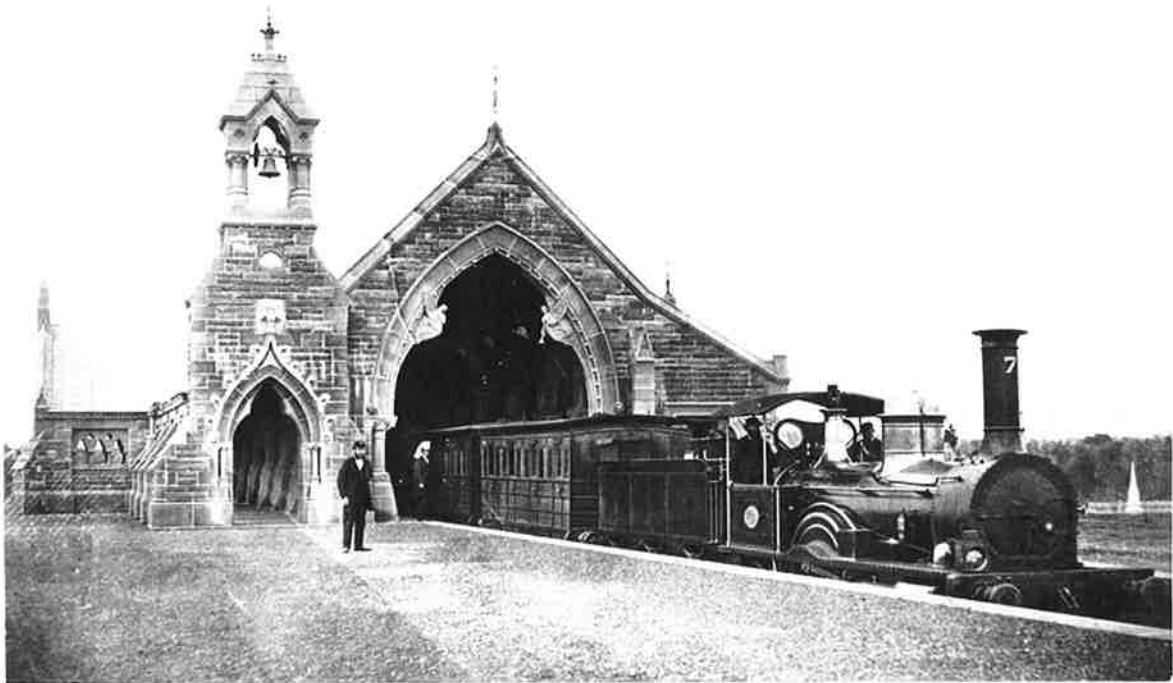
Figure 3.4 The Necropolis main station c1897 after the line was extended and the station building altered to allow trains to proceed down the line. The fine stonework and gothic style are clear in this image. The station was dismantled in 1957 and reassembled as a local church in Canberra, where it remains. (Source: SRNSW)

Mortuary Station No. 1 (Item 3)	<ul style="list-style-type: none"> Station designed by James Barnet, Colonial Architect (Figures 3.2 and 3.4).

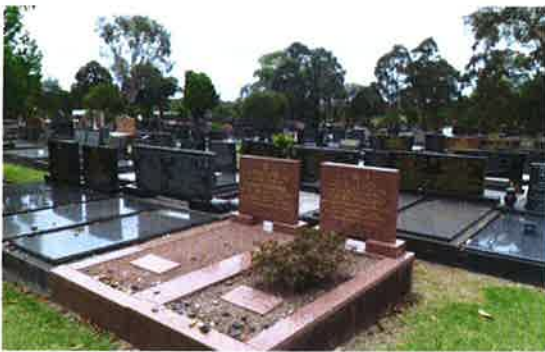
Figure 4.1 Example of high density contemporary burials in the Jewish cemetery. (Source: GML 2015)

- Much of the terrain within the study area consists of manicured lawns containing a high density of internments (Figures 4.1 and 4.2).
- Landscaping in the vicinity of older internment areas is less strictly managed and there is some potential for internments or landscape features to be obscured by overgrowth (Figures 4.3 and 4.4).

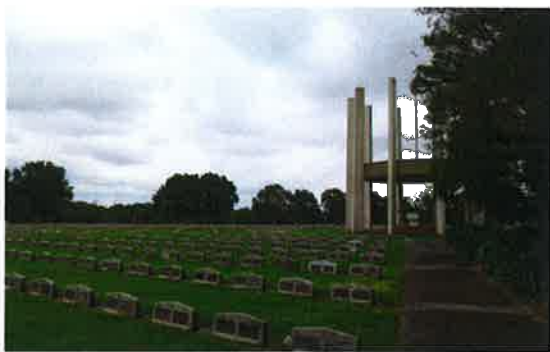
Figure 4.2 Example of high density burials surrounding the 'Crown of Thorns' shrine within the Catholic cemetery. (Source: GML 2015)

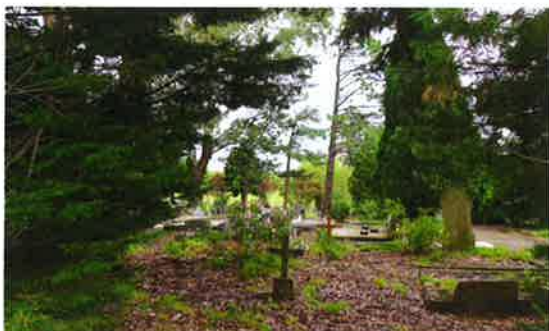
Figure 4.3 Example of overgrown burials within historical sections of Rookwood. (Source: GML 2015)

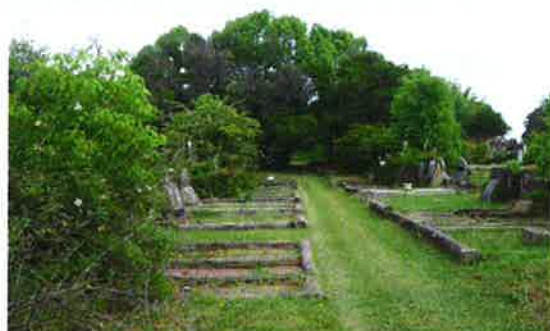
Figure 4.4 Example of slightly overgrown historical burials within Rookwood. (Source: GML 2015)

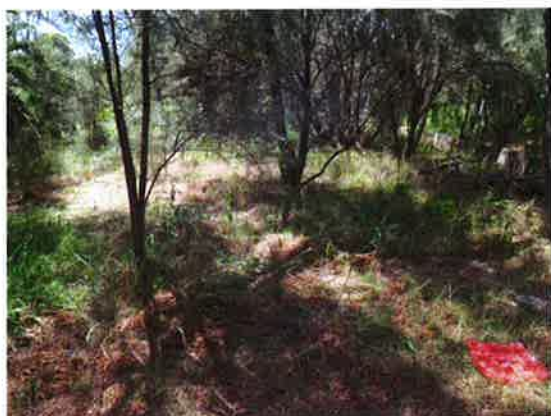
Figure 4.5 Area of unmarked pauper burials in the northwest sector of the study area (MU#11, Independent and Catholic). (Source: GML 2015)

- Evidence of unmarked internments was encountered within the western portion of the study area (previously used for paupers' graves), as a few scattered grave markers and location markers were located (Figures 4.5 and 4.6).

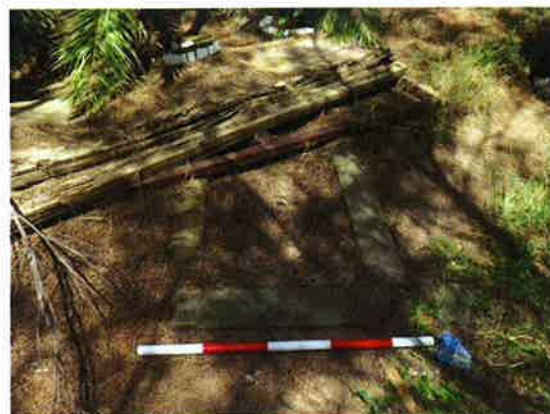
Figure 4.6 Example of a marked pauper burial within the area of unmarked burials shown in Figure 4.5. (Source: GML 2015)

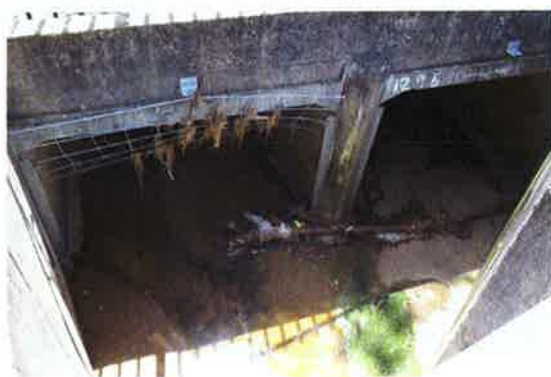
Figure 4.7 Exit point of Canal #5 (Rookwood Main Branch) beneath East Street along the western boundary of the study area. (Source: GML 2015)

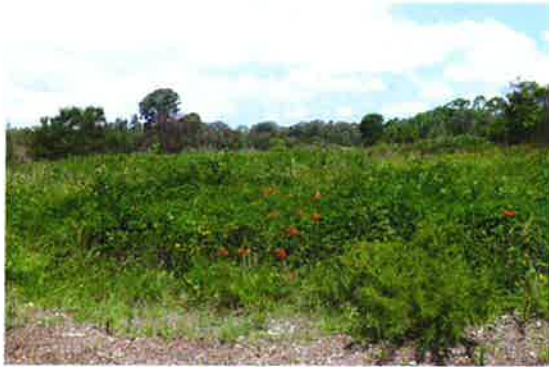
Figure 4.11 Area identified as being marshy and subject to regular flooding within the northwest sector of the study area on the east side of Canal #5 (MU#11, Independent and Catholic). (Source: GML 2015)

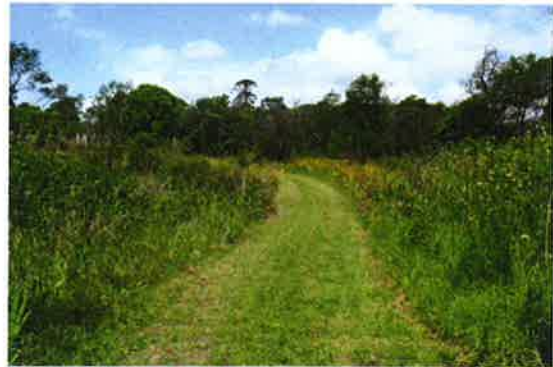
Figure 4.12 View south along Oliver Avenue showing the growth of dense vegetation in an area known to flood fairly regularly (MU#8, Presbyterian No. 1). (Source: GML 2015)

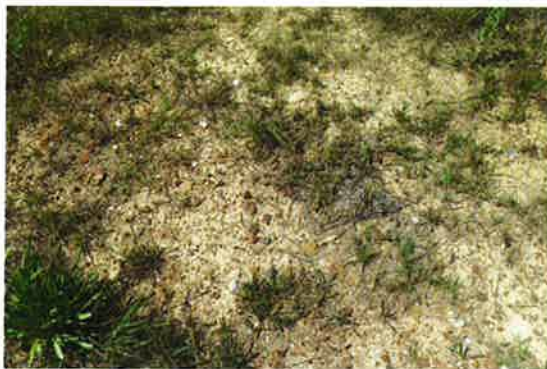
Figure 4.13 Deposit of fine beige alluvium with fine gravels present within identified flood-prone areas in the northwest sector of the study area. (Source: GML 2015)

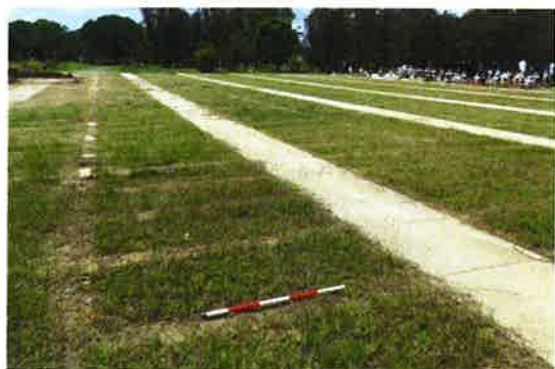
Figure 4.14 Flood prone areas bulk-excavated and laid with concrete in advance of internment, located on the north side of Canals #10A and #10B, MU#10 (Independent). (Source: GML 2015)

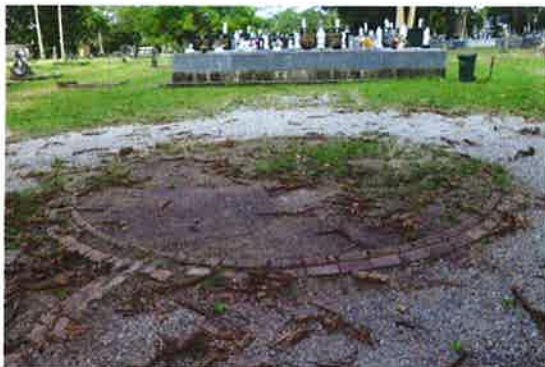
Figure 4.15 Circular brick layout element located within MU#9 (Catholic) in the southwest vector of the study area. (Source: GML 2015)

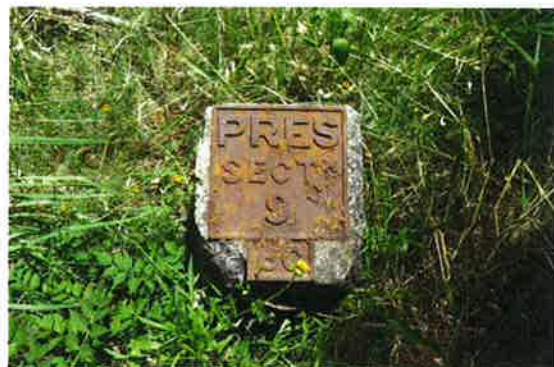
Figure 4.16 Locational marker partially obscured by vegetation within a heavily overgrown portion of the study area, MU#8 (Presbyterian No. 1). (Source: GML 2015)

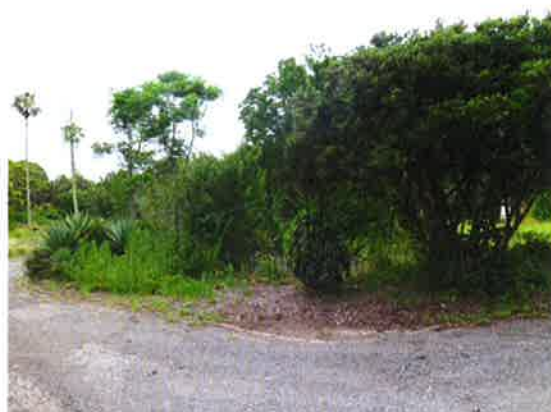
Figure 4.17 Gravel road/path with brick spoon drain situated within the SHR curtilage of the study area. (Source: GML 2015)

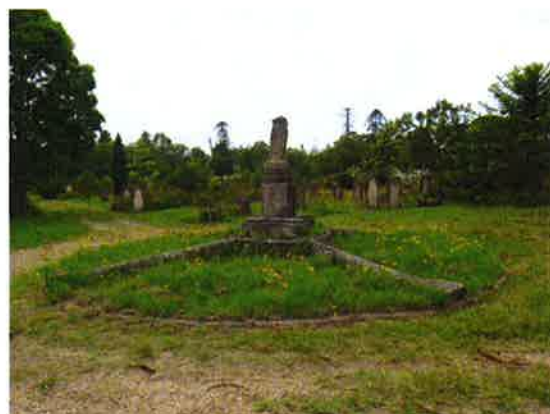
Figure 4.18 Unidentified partially buried sculptural element located within the northwest sector of the study area (MU#3, Anglican Area No. 1). (Source: GML 2015)

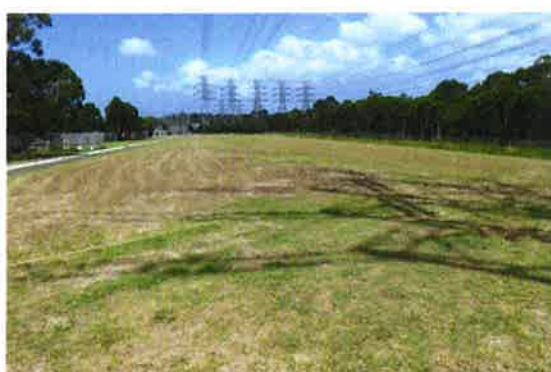
Figure 4.19 View to the northeast of the large electrical transmission towers situated within an area of Aboriginal archaeological potential in MU#24 (Lot 10 and 7053). MU#24 is visible to the right as the forested area separated from the open lawn by a fence. (Source: GML 2015)

- The construction of transmission towers would have resulted in localised disturbance to any archaeological deposits in the area (Figure 4.19).
 - The area was identified as containing Cooks River Castlereagh Ironbark forest and is densely vegetated (Figures 4.20 and 4.21), inhibiting the ability to search for surface expressions of Aboriginal objects.

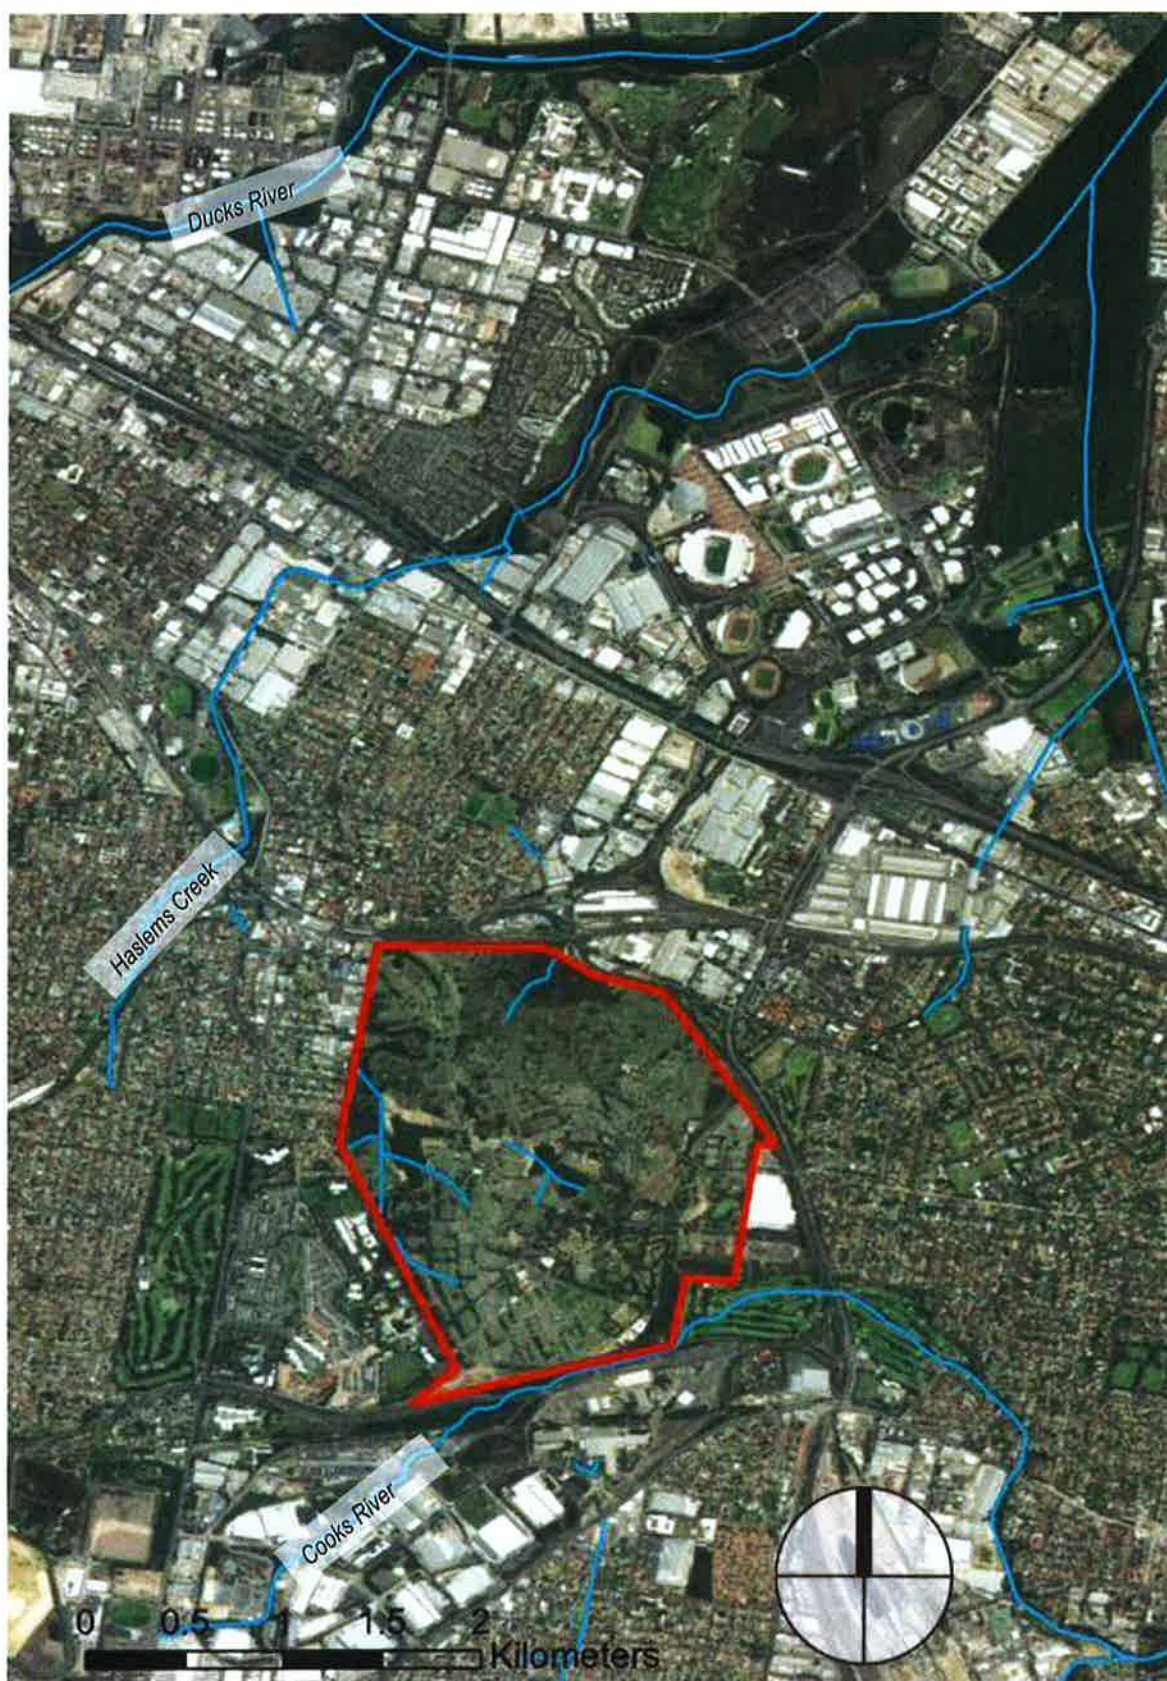
Figure 5.3 Waterways in the vicinity of the study area. Note that the waterways within the study area are actually canals, and the waterway depicted northeast of the study area is also part of a canal system. (Source: ArcGIS with GML additions 2016)

The study area is situated in the immediate vicinity of one waterway, the Cooks River (Figure 5.3). This river extends along the southern boundary of the study area and would be characterised as a first order water course in the vicinity of the study area. Cooks River drains to the southeast and is gradually fed by several minor water courses before draining into Botany Bay immediately west of the Sydney Airport.

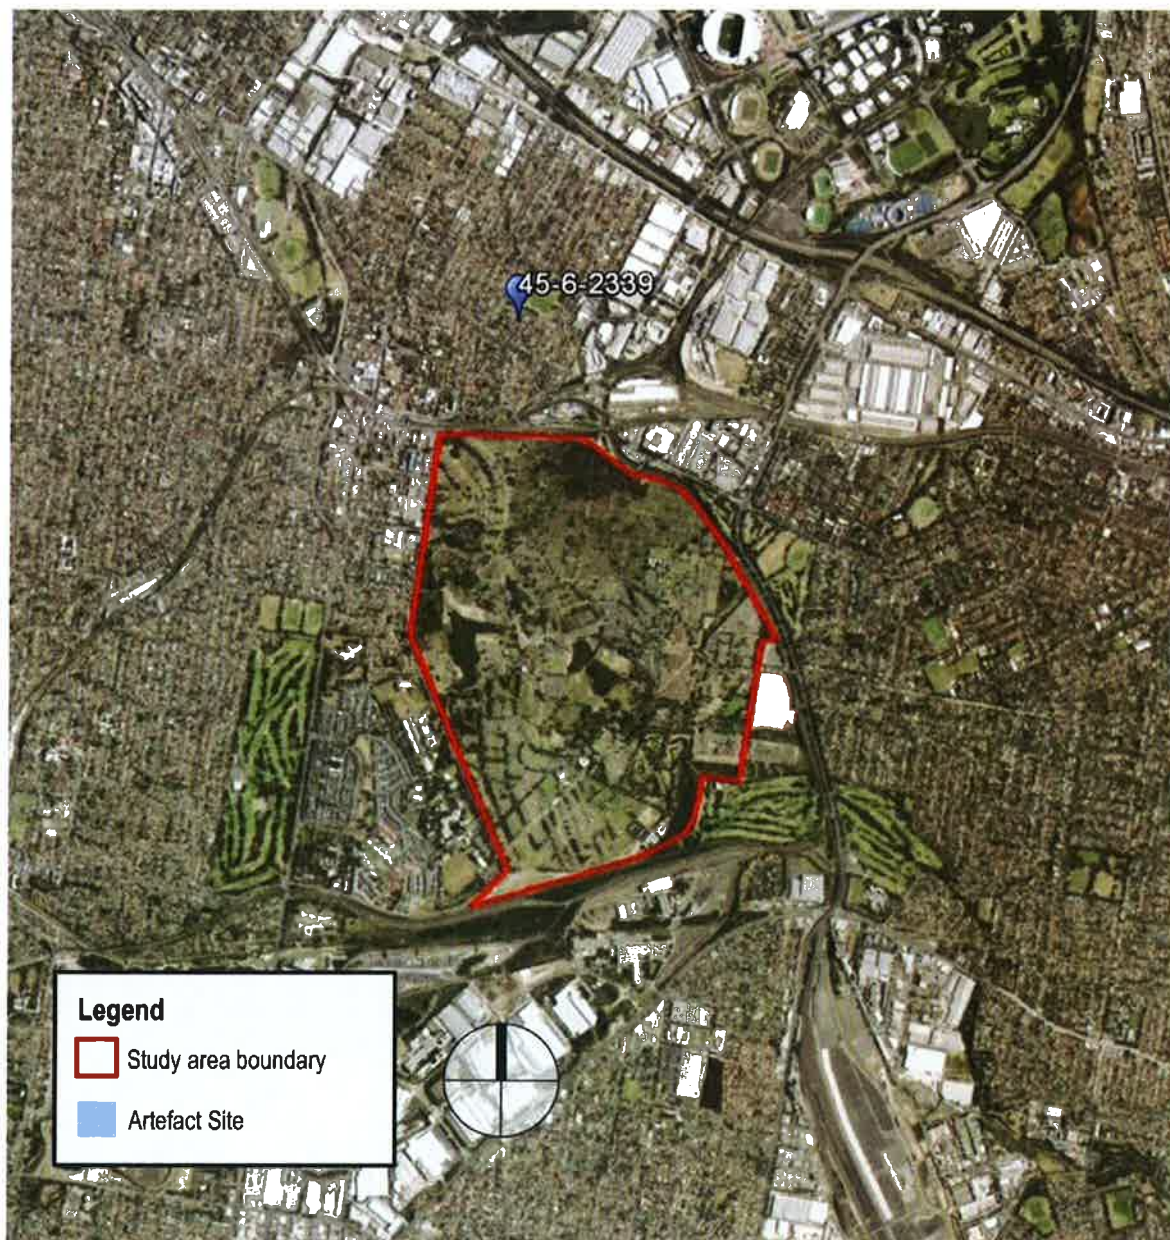
Figure 5.4 Results of an AHIMS search with a 1km buffer around the Rookwood study area. (Source: AHIMS, Google Earth Pro with GML additions 2015)

An extensive search of the AHIMS database administered by the OEH was conducted on 29 October 2015 (Appendix A) with a 1000m buffer; one registered site was identified (Figure 5.4).

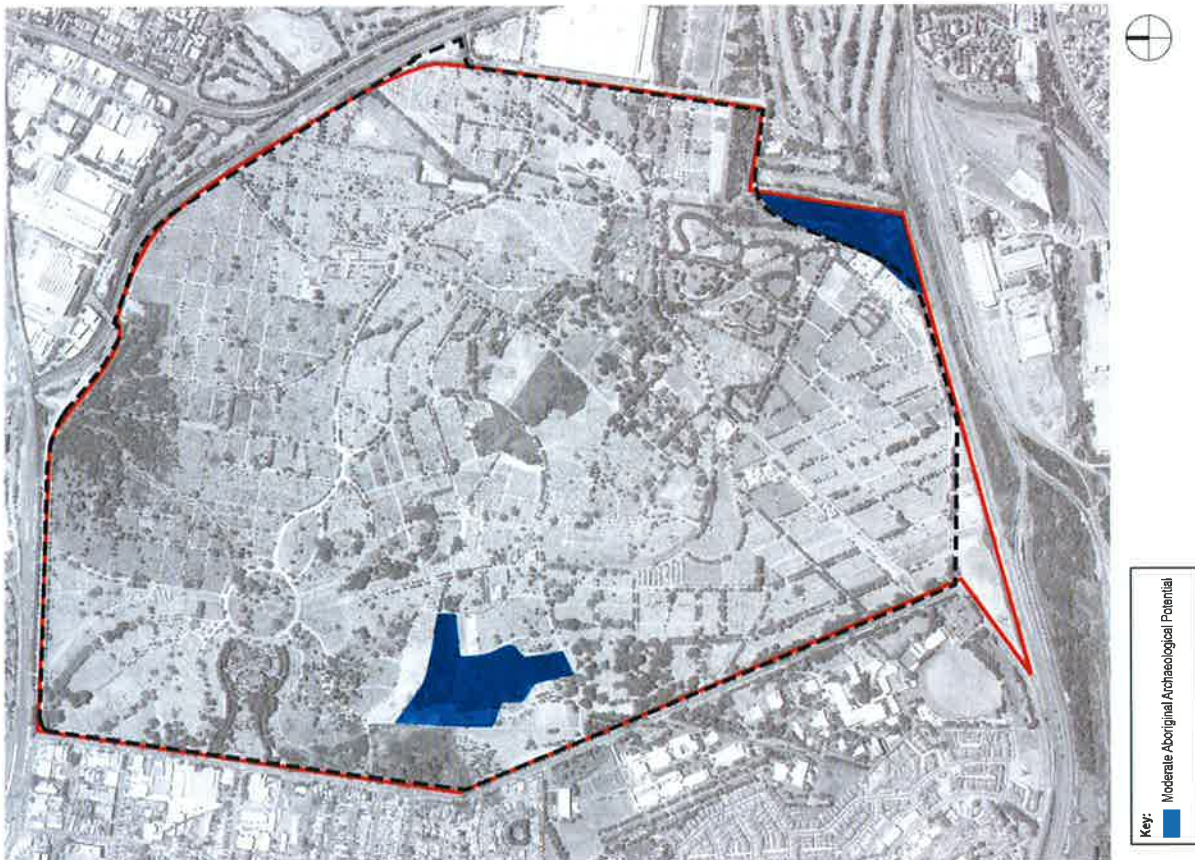
Figure 5.5 Aboriginal archaeological potential of Rookwood. The majority of the site has low or no Aboriginal archaeological potential (uncoloured) while areas of moderate Aboriginal archaeological potential are marked in blue. (Source: Google Earth Pro with GML additions 2016)

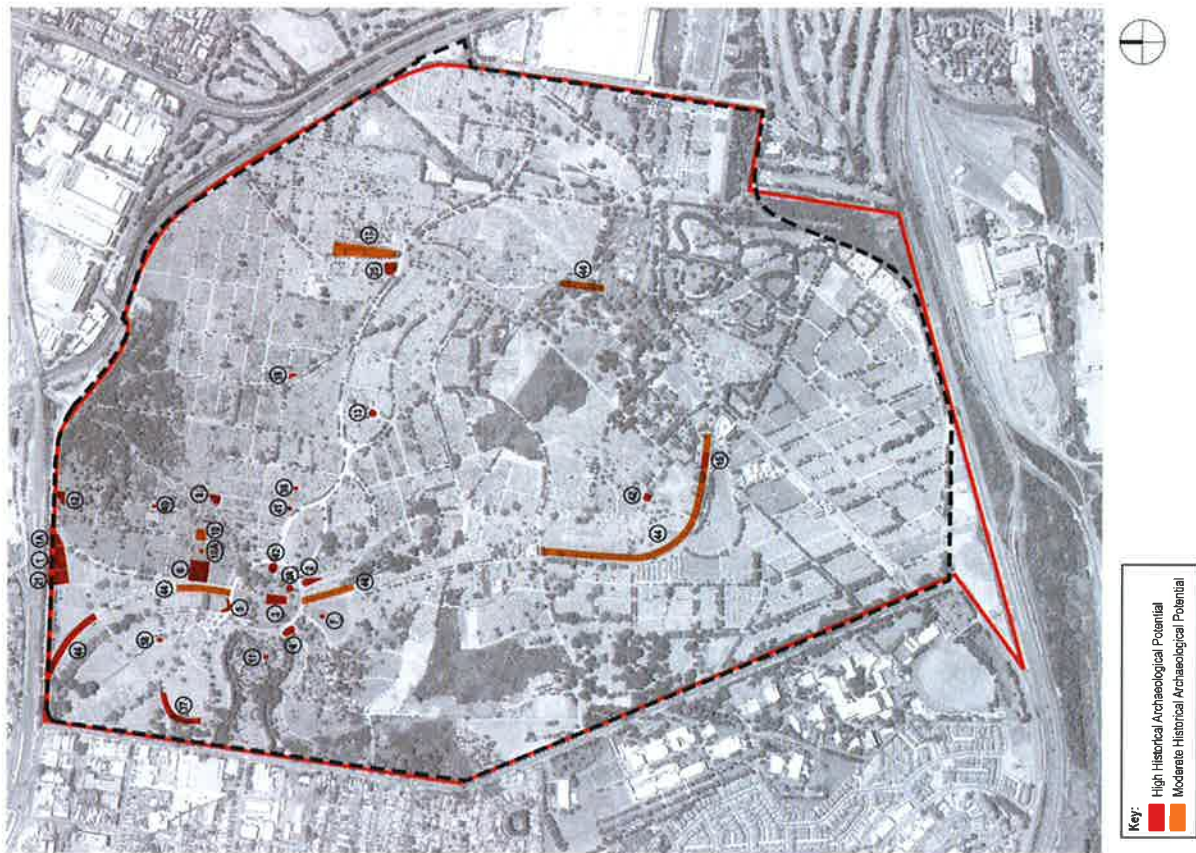
Figure 6.1 Historical archaeological potential of Rookwood as indicated by the presence of anticipated non-interment sites (Source: Google Earth Pro with GML additions 2016)

be found as a result of each phase of use. Sites previously identified by Lavelle (1996) or located during site survey are presented in greater detail in Section 6.5.1 below. The locations of identified archaeological items are presented in Figure 6.1.

Phase	Types of Archaeological Evidence	Likelihood of Survival	Location
4: 1879–1895 Rookwood Necropolis Expansion and Growth	<ul style="list-style-type: none"> burnt tree boles associated with land clearing; landscaping and infrastructure including roads, paths, and drains; recorded human internments, including grave furniture; grave elements and minor burial-related objects; and unmarked human internments, associated with grave elements and burial-related objects. <p>The following identified sites associated with this phase are located within the study area:</p> <ul style="list-style-type: none"> Lattice Rest House (Ladies Only) (Item 10); Lattice Shelter/Rest House (Item 10A); Lattice Rest House (Item 11); Lattice Rest House (Item 12); Glass and Brush House (part of Item 5); and Rest House and Workers Change Room (Item 13). 	<p>Low</p> <p>Moderate</p> <p>High</p> <p>Low</p> <p>Moderate</p> <p>High</p>	<p>Areas beyond the original 200 acre land grant</p> <p>Entire study area</p> <p>See Figure 6.1</p>

5: 1896–1948 Railway Extension and Removal	<ul style="list-style-type: none"> landscaping and infrastructure including roads, paths, and drains; recorded human internments, including grave furniture; grave elements and minor burial-related objects; and unmarked human internments, associated grave elements and burial-related objects. <p>The following identified sites associated with this phase are located within the study area:</p> <ul style="list-style-type: none"> Toilet Block No. 1 Mortuary Station (Item 3A); Mortuary Station No. 3 (Item 15); Former Pond and Fountain, 'Twins' Sculpture (Item 36); Ornamental Pond (Item 38); Dead End Railway Siding (Item 17); Lattice Rest House/Ladies Lavatory (Item 18); Residence (Keating Family) (Item 21); Weatherboard House/Kiosk (Item 25); and Railway Corridor (Item 44). 	<p>Moderate</p> <p>High</p> <p>Low</p> <p>High</p> <p>Moderate</p> <p>High</p> <p>Moderate</p>	<p>Entire study area</p> <p>See Figure 6.1</p>

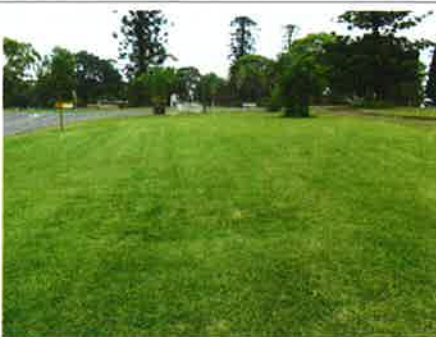
MU #12	<ul style="list-style-type: none"> The Sextons cottage was first constructed sometime between 1867 and 1873. 	
First constructed c1870 Demolished c1960	<ul style="list-style-type: none"> Evidence associated with the Independent Sexton's House might include remains of the cottage, outbuildings, sealed artefact deposits associated with use and landscaping features such as road surfaces/paving, kerbs, drains and fencing. 	
High archaeological potential	<ul style="list-style-type: none"> The area appears to have been subjected to little or no disturbance, and with structural remnants visible in situ this site has high archaeological potential (Figure 6.4). 	Figure 6.4 View to the northwest across the site of the Independent Sexton's house.

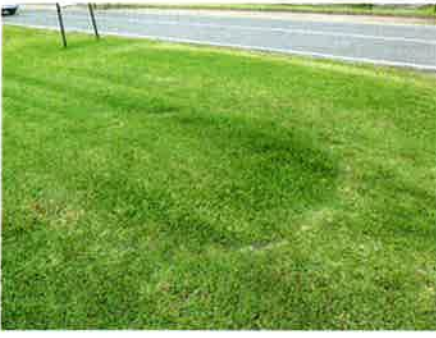
State significance	<ul style="list-style-type: none"> During site survey the brick outline of a well or cistern was encountered (Figure 6.5), along with a small square concrete footing, possibly from a later outbuilding or feature.

Figure 6.5 Outline of a well or cistern located within the site of the Independent Sexton's house.

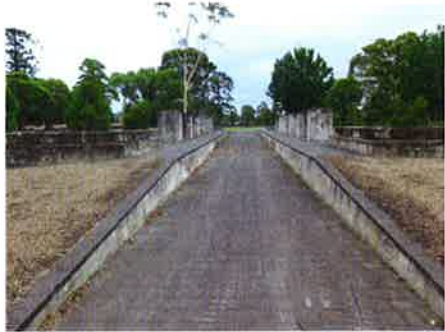
MU #7	<ul style="list-style-type: none"> The Necropolis Branch railway line was extended in 1897, which required alterations to the station. 	
First constructed 1869 Demolished 1957	<ul style="list-style-type: none"> Test excavations of the site by Lavelle in 1992 identified extensive footings and fill deposits surviving at and below the present surface.⁹ 	
High archaeological potential	<ul style="list-style-type: none"> The remains of Mortuary Station No. 1 have been integrated into an interpretive alignment meant to illustrate the layout of the station (Figure 6.6). Structural elements of the station likely remain intact beneath the concrete, gravel and paving. 	
State significance	<ul style="list-style-type: none"> Evidence associated with Mortuary Station No. 1 might include remains of the station, outbuildings, sealed artefact deposits from interior and exterior spaces, remains of rail infrastructure/machinery, and landscaping elements. 	<p>Figure 6.6 Ruins of Mortuary Station No. 1 (and additional interpretive elements), view to north.</p>

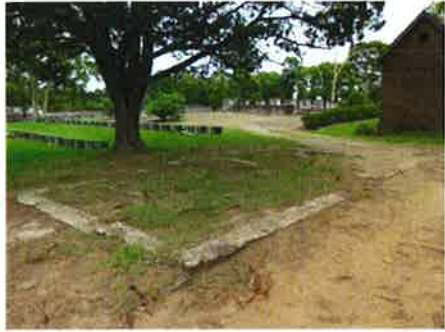
MU #7	<ul style="list-style-type: none"> Stone footings of the toilet block are visible within the study area, suggesting that the site has been subject to little or no disturbance (Figure 6.7). 	
First constructed c1890 Demolished 1957	<ul style="list-style-type: none"> Evidence associated with the toilet block might include structural remains of the toilet block, remnants of services, sealed artefact deposits associated with use of the toilet block (particularly if sewerage was not established immediately) and landscaping elements (paths, etc) associated with the toilet block. 	
High archaeological potential		
Local significance		<p>Figure 6.7 Exposed footings from the toilet block for Mortuary Station No. 1, view to northwest.</p>

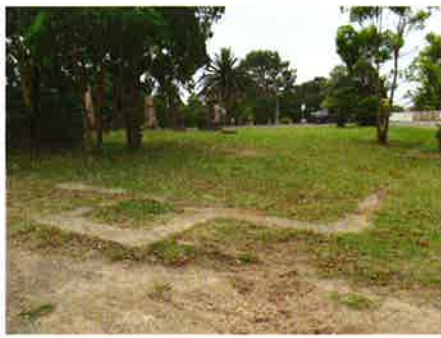
MU #4	<ul style="list-style-type: none"> Original building was a large two-storey gothic building with garden areas (Figure 3.2). 	
First constructed c1870 Demolished c1960	<ul style="list-style-type: none"> Stone footings associated with the Presbyterian Office/Residence are visible within the study area. They appear relatively intact suggesting that they have been subject to little or no disturbance since demolition (Figures 6.8 and 6.9). 	
High archaeological potential

Figure 6.8 Exposed footings of the Presbyterian office/residences, view to northwest.

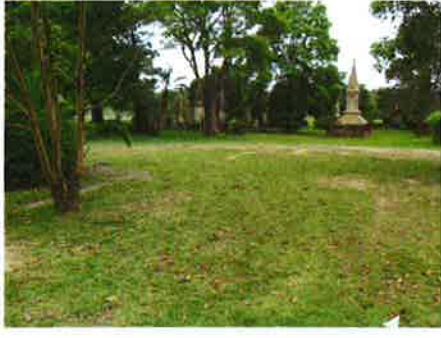
Figure 6.9 Exposed footings of the Presbyterian office/residences, view to southeast.

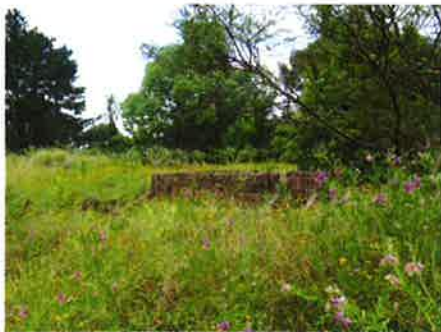
<p>Anglican Managers Residence and Complex (including Workshop, Store and Nursery) (Item 6)</p> <p>MU #3</p> <p>First constructed c1873 Demolished 1970</p> <p>High archaeological potential</p> <p>State significance</p>	<ul style="list-style-type: none"> This site initially consisted of a complex centred on a gothic-styled two-storey residence with a complex of garden areas and a nursery. The nursery and greenhouse were extended in the 1880s and 1890s, and the residence was renovated in the 1920s. Sandstone footings, brick footings, dwarf walls and garden elements were encountered during the site inspection (Figure 6.12). These elements reflect what appears to have been a sizeable complex of buildings and working areas (Figure 6.13). At present the site is heavily overgrown and contains stockpiles of demolition rubble, with no evidence of other disturbance. It is highly likely that much of this site remains intact. Evidence associated with this site might include remains of the original structure, outbuildings (such as the nurseries and greenhouse), sealed artefact deposits associated with use and landscaping features such as gardens, road surfaces/paving and fencing.

<p>Figure 6.12 Brick ruins within the site of the Anglican Managers Residence and Complex.</p>

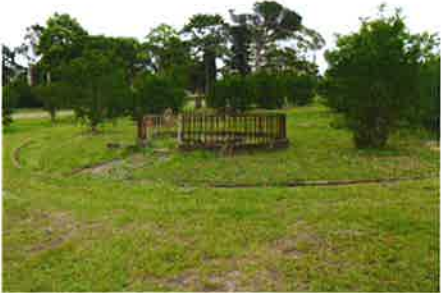
<p>Unidentified Chinese Element (Item 7)</p> <p>MU #8A</p> <p>First constructed 1877 Not fully demolished</p> <p>High archaeological potential</p> <p>State significance</p>	<ul style="list-style-type: none"> Situated immediately north of the Quong Sin Tong pagoda/altar. Site consists of an altar stone enclosed within a wrought-iron fence and a brick roundel (Figure 6.14). The function and full extent of the site is unknown, but further investigation and reinstatement of the neighbouring Quong Sin Tong pagoda/altar proved fruitful. Further investigation of this feature could provide some insight into its original extent and function. Archaeological evidence associated with this feature would likely be limited to structural elements such as paving, edging, kerbs and possibly lost architectural elements.

<p>Figure 6.14 Unidentified element opposite the Quong Sin Tong pagoda/altar, view to west.</p>

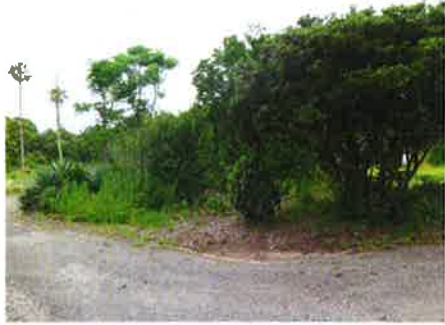
MU #3	<ul style="list-style-type: none"> No visible remains were encountered, but the arbour was shown in a c1900 photograph and Lavelle (1996) identified this location as most probable to contain it. 	
First constructed c1878 Demolished c1940	<ul style="list-style-type: none"> A demolition date in the 1930s was originally proposed by Lavelle, though the arbour is still visible in a 1943 aerial photograph (Figure 6.15). The shed/arbour was likely demolished sometime in the 1940s. 	
High archaeological potential	<ul style="list-style-type: none"> The proposed location of the arbour is an overgrown ornamental garden plot with a brick spoon drain bordering its edges. There is no evidence of ground disturbance or works in this area (Figure 6.16).

<p data-bbox="954 1151 1401 1227">Figure 6.16 Likely location of the former shed/ornamental arbour for clergy, view to northeast.</p>

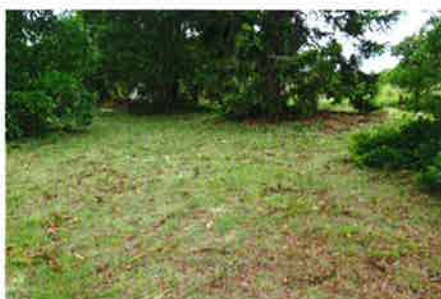
<p>Lattice Rest House (Ladies Only) (Item 10)</p>	<ul style="list-style-type: none"> The site initially consisted of a timber lattice rest house with multiple entrances and an elaborate roof form. A historical photograph of the buildings suggests that it was situated within a complex pathway system with garden beds and shrubs and a terracotta urn. This area appears to have been subject to minimal disturbance (Figure 6.17). The layout of an elaborate system of gardens and paths visible in aerial photographs of the site from 1943 are still evident in the landscape. This site retains high historical archaeological potential for remains associated with the lattice rest house. Associated historical archaeological evidence might include structural remains of the rest house (footings), landscape elements such as gardens, kerbing, paths, drains and the base of the terracotta urn. Given that use of this feature would have been relatively ephemeral there is some potential for isolated artefacts associated with its use.

<p>MU #3</p>		
<p>First constructed c1880 Demolished c1950</p>		
<p>Moderate archaeological potential</p>		
<p>Local significance</p>		<p>Figure 6.17 Potential site of the former ladies only lattice rest house.</p>
<p>Lattice Shelter (Item 10A)</p>	<ul style="list-style-type: none"> The lattice rest shelter was identified as having formerly occupied a small roundel within Section B of the No. 1 Anglican Cemetery. No archaeological remains were evident during the site inspection (Figure 6.18) and it is not certain that this is the correct location of the site. As such, this location has only moderate potential to contain the remains of the lattice shelter. Evidence associated with the lattice shelter might include structural remains (footings) and isolated artefacts (lost or discarded) associated with its use.

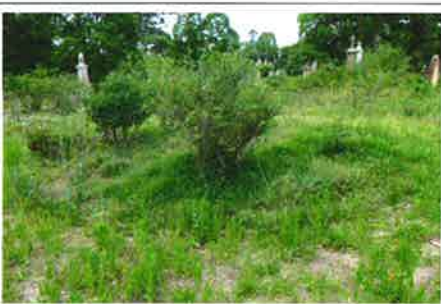
<p>Local significance</p>		<p>Figure 6.18 Potential site of the former lattice shelter.</p>

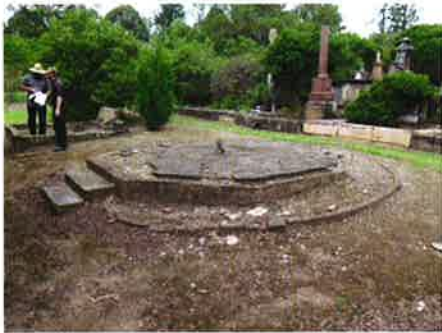
Lattice Rest House (Item 11)	<ul style="list-style-type: none"> The ruins of this lattice rest house are consistent with several other octagonal timber lattice rest houses constructed within No. 1 Wesleyan Cemetery and Sections 1 and 2 of the Anglican Cemetery. The footings of the rest house are dry-pressed brick and the floor surface and steps are concrete rendered. Oral accounts of the site suggest that it may have also functioned as an office. This site is currently a partial ruin and therefore has high archaeological potential. Archaeological evidence might include additional structural elements or landscaping features such as gardens, kerbs, paths and drains. Isolated artefacts associated with use of the rest house may be encountered. If the site were in fact used as an office there would be some potential for sealed artefact deposits in the immediate vicinity of the structure.

Figure 6.19 Remains of lattice rest house, view to north.

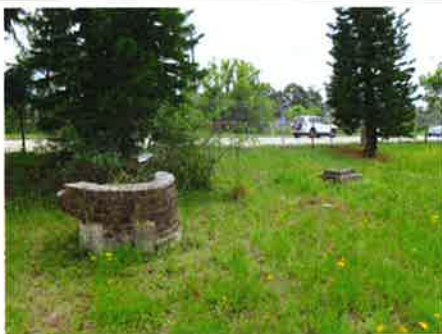
MU #1		
First constructed c1880 Demolished c1960		
High archaeological potential		
Local significance		
Lattice Rest House (Item 12)	<ul style="list-style-type: none"> The main rest building was initially a large, rectangular structure built of timber lattice with small, decorative projecting porches located at entry points. This portion of the site is located beneath Railway Street. A small weatherboard building, identified as a Hearse Shed, was situated in proximity to the rest house, and by 1913 it was converted to an employee lunch room. Visible remnants within the current Rookwood boundary consist of a partially rendered brick cistern/well and an urn base (Figures 6.20 and 6.21). The cistern/well may contain sealed artefact deposits which could provide insight into activities in this area. There is high potential for additional artefact deposits associated with use of the rest house, Hearse Shed and employee lunch room. Structural remains associated with the Hearse Shed and other unidentified outbuildings may remain in the area, as well as landscaping features such as paving, paths, kerbs, gardens and drains.

Figure 6.20 View to the northeast towards Railway Street of the brick cistern/well and urn base.

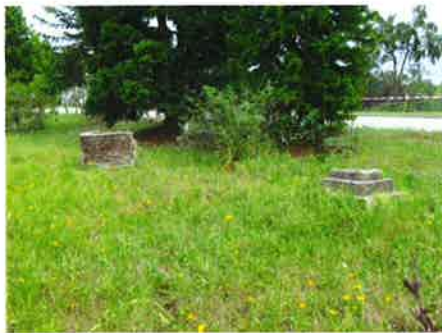
Figure 6.21 View to the northwest towards Railway Street of the brick cistern/well and urn base.

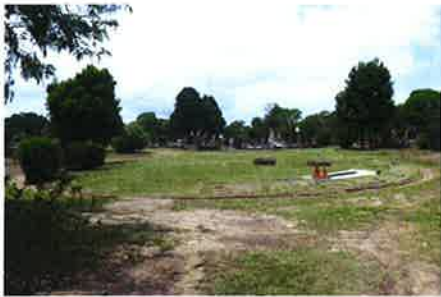
Rest House and Workers Change Room (Item 13)	<ul style="list-style-type: none"> The area contained within a large brick-paved roundel in No. 2 Jewish Cemetery previously contained a small timber or weatherboard building used as a rest house and workers' change room. There is little to no evidence of later disturbance in this area, with the exception of the outer margins of the roundel in which juvenile burials have commenced (Figure 6.22). Archaeological evidence in this area might include structural remains, isolated artefacts associated with ephemeral use of the building as a rest house, sealed artefact deposits resulting from use as a change room, and landscaping elements such as paths, gardens, kerbs and drains.

<p>Figure 6.22 View east towards the site of the former rest house and workers' change room. Note that burials have commenced within the brick paved roundel said to contain these archaeological remains.</p>

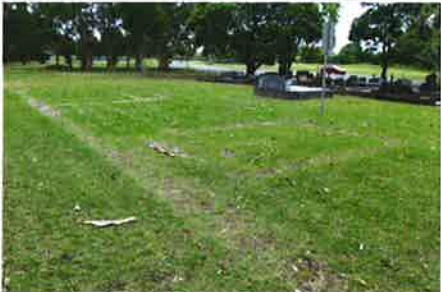
MU #14A		
First constructed c1890 Demolished c1970		
High archaeological potential		
State significance		
Mortuary Station No. 3 (Item 15)	<ul style="list-style-type: none"> Mortuary Station No. 3, initially opened as the Mortuary Terminus in 1897, consisted of a stone building with two ornamental towers. Remains of the station have been subject to minimal disturbance and sandstone footings of the station are visible in an area of open lawns on the south side of Weekes Avenue near the Catholic Cemeteries and Crematoria offices (Figures 6.23 and 6.24). There is high potential for archaeological evidence associated with the station to remain intact within the study area. Evidence associated with Mortuary Station No. 3 might include remains of the station, outbuildings, sealed artefact deposits from interior and exterior spaces, remains of rail infrastructure/machinery, and landscaping elements.

<p>Figure 6.23 Sandstone footings of Mortuary Station No. 3, view to northwest.</p>

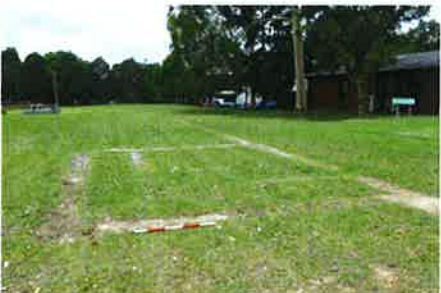
<p>Figure 6.24 Sandstone footings of Mortuary Station No. 3, view to east.</p>

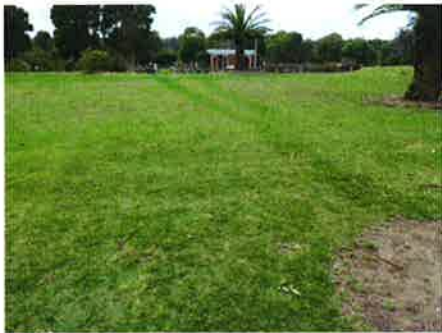
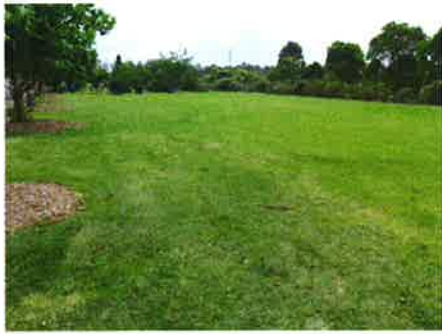
Dead-End Railway Siding (Item 17)	<ul style="list-style-type: none"> Constructed in 1908 as part of the final railway line branch extension. Rookwood line closed and the railway track was removed in 1948. Much of this portion of the study area is currently an open, seemingly undisturbed grassed area (Figures 6.25 and 6.26). A turfed parking enclosure and gardens/shrubs is present in the northern portion of the Dead-End Railway Siding area in association with the All Souls Chapel. There is no indication that these works would have resulted in anything beyond minor disturbance to potential archaeological remains. As the tracks themselves were removed there is moderate potential for archaeological evidence associated with the railway formation to remain intact within the study area.

First constructed 1908 Demolished 1948		
Moderate archaeological potential		
Qualifies as a 'work' under the Heritage Act		<p>Figure 6.25 View east from Hawthorne Avenue across the area thought to contain remains of the railway siding.</p> <p>Figure 6.26 View to the north across the grassed surface through to contain remains of the railway siding.</p>
