9.0 Appendices

Heritage Asset Management Sheets

Rookwood Archaeological Assessment (AA)

GML Heritage

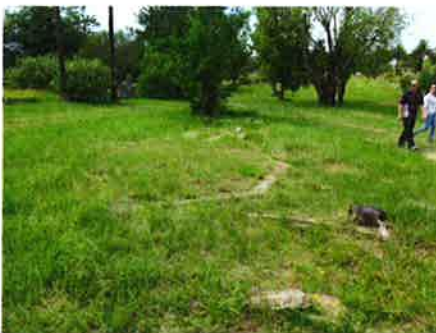
Figure 6.27 Overview of the lattice rest house/ladies lavatory sit with brick octagonal footings visible.
MU #4	<ul style="list-style-type: none"> The structures associated with this site were demolished in c1970. 		
First constructed 1908 Demolished 1948	<ul style="list-style-type: none"> Visible remains include the footings of an octagonal structure, brick paving and kerbs, and a concrete pad with evidence of glazed ceramic sewerage pipes (Figures 6.27 through 6.29). 		
High archaeological potential	<ul style="list-style-type: none"> Dry-pressed brick paving extends on the northwest side of the octagonal structure while a concrete pad is situated on its south side.

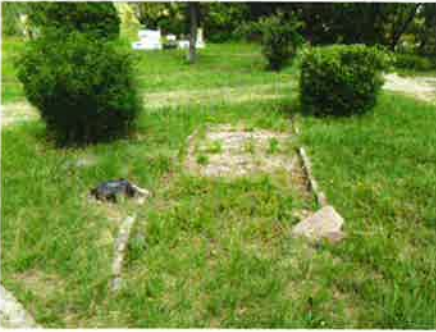
Figure 6.28 Brick paving with brick kerb extending northwest from the brick footings.

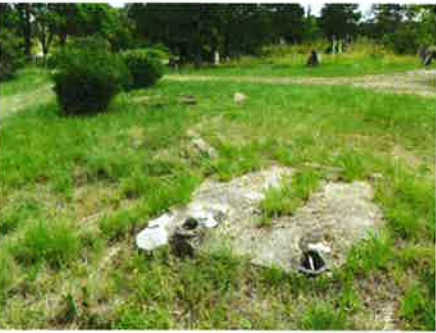
Local significance	<ul style="list-style-type: none"> The site has high archaeological potential for remains associated with the lattice rest house and ladies lavatory. This evidence would include structural remains of the building, service pipes, landscaping elements including paving, kerbs, paths and drains, as well as isolated artefacts resulting from use of the site.

Figure 6.29 Concrete pad with evidence of sewerage pipes on the south side of the octagonal structure.

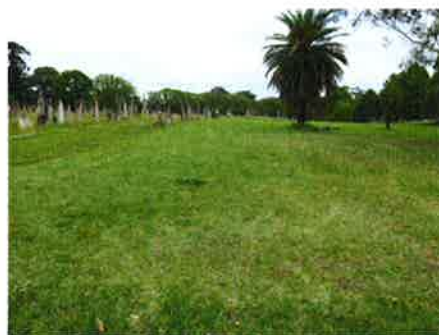
Residence (Keating Family) (Item 21)	<ul style="list-style-type: none"> A brick house was constructed for and occupied by the family of E Keating, Manager of the Catholic Cemetery from 1898 until his death in 1938.
MU #2	
First constructed 1920 Demolished c1940	<ul style="list-style-type: none"> There has been no further development in this area and, while no archaeological evidence was visible, the site has high archaeological potential for remains associated with the Keating residence (Figures 6.30 and 6.31).
High archaeological potential	
Local significance	<ul style="list-style-type: none"> Evidence associated with the Keating residence might include remains of the house, outbuildings, sealed artefact deposits associated with use and landscaping features such as gardens, road surfaces/paving, kerbs, drains and fencing.

Figure 6.30 Location of former Keating family residence, view to east.

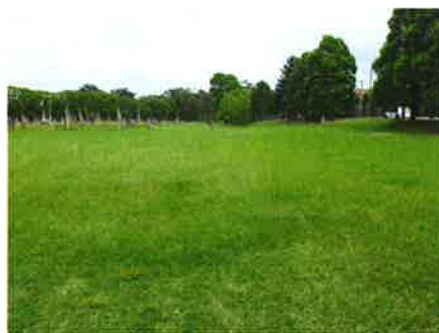
Figure 6.31 Location of former Keating family residence, view to west.

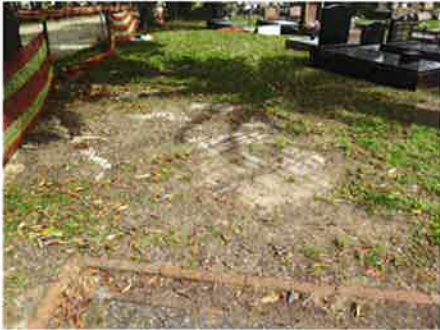
MU #4	<ul style="list-style-type: none">Brick paving/footings and concrete remnants remain in situ at the rear (west) of the extant brick kiosk (Figures 6.32 and 6.33).	
First constructed 1928 Demolished c1970	<ul style="list-style-type: none">Internments appear to have extended into this area and impacted on the remains of the kiosk after the last review in 1996.	
High archaeological potential	<ul style="list-style-type: none">There is high potential for archaeological evidence associated with the kiosk to remain within the identified portion of study area.	
Local significance	<ul style="list-style-type: none">Evidence might include structural remains of the kiosk, flower stalls and toilets, as well as associated landscaping including paths, kerbs, paving, drains and services.

Figure 6.32 View to west of brick paving, brick footings and concrete remnants.

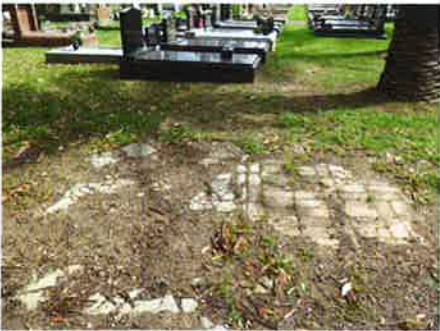
Figure 6.33 View to northwest of brick paving and concrete remnants of the septic tank or toilets.

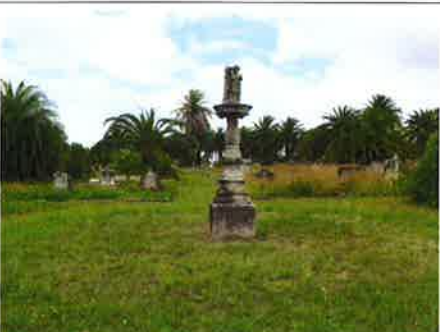
MU #3	<ul style="list-style-type: none">The site appears to have remained undisturbed since the initial removal of the pond.	
First constructed 1899 Partially demolished c1970	<ul style="list-style-type: none">The outline of the pond is clearly visible in the grass surrounding the 'Twins' sculpture (Figure 6.34).	
High archaeological potential	<ul style="list-style-type: none">There is high potential for archaeological evidence associated with the fountain to remain within the study area.	
State significance

Figure 6.34 The 'Twins' sculpture with the outline of the former pond visible in the surrounding area.

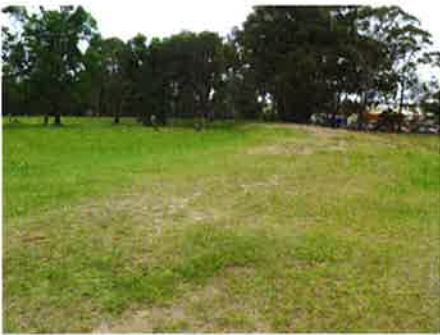
Semicircular Embankment (Item 37)	<ul style="list-style-type: none"> This large, curved embankment is situated in an area which was developed and utilised from when the cemetery was first established (Figure 6.35).

MU #2	<ul style="list-style-type: none"> The function of the semicircular embankment is not known, though it may have been part of an earlier landscape element or worked to control the flow of stormwater within the cemetery. 	
First constructed c1880		
High archaeological potential		
State significance	<ul style="list-style-type: none"> Archaeological investigations and further research might provide insight into the function and date of construction for this feature. Archaeological evidence associated with this feature might include a structural framework for the embankment and fill deposits for building it up, as well as isolated artefacts associated with loss during construction.

Figure 6.35 View to the southwest of the semicircular embankment from its northern edge.

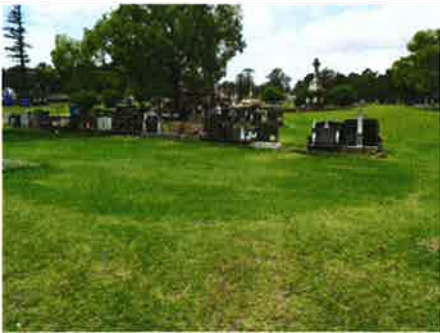
MU #2	<ul style="list-style-type: none"> Although the pond has been removed, a circular outline thought to be associated with the pond is still visible within its former location (Figure 6.36). There is high potential for archaeological evidence associated with the pond to remain in this part of the study area. 	
First constructed c1900 Demolished c1970		
High archaeological potential		
State significance	<ul style="list-style-type: none"> Burials are currently infringing on the eastern and southern sides of the 'pond' (Figure 6.37). Archaeological evidence would likely be limited to the structural remains of the pond and the associated drain and culvert system which formerly fed it.

Figure 6.36 Site of the former pond, view to southeast.

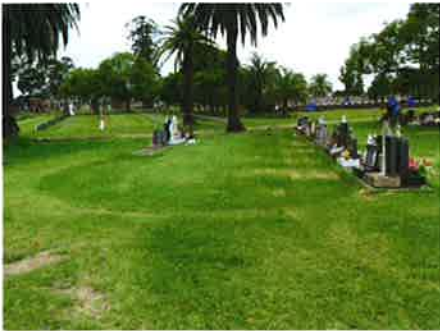
Figure 6.37 Site of the former pond, view to east. Note the internments extending into the visible outline of the pond.

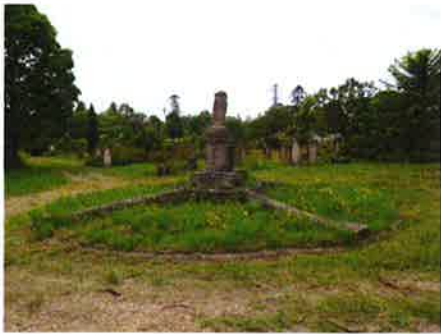
Unidentified Sculptural Feature (Item 40)	<ul style="list-style-type: none"> This undated feature consists of a stone sculpture, the lower body of a robed figure, on a stone plinth (Figure 6.38).

MU #3	<ul style="list-style-type: none"> The sculpture has a surrounding consisting of a ring of concrete with four arms radiating out from the sculpture. Sea shells have been pressed into the surfaces of the surround. 	
High archaeological potential	<ul style="list-style-type: none"> At the distal end of each 'arm' is a rectangular brick base rendered in concrete. 	
Local significance	<ul style="list-style-type: none"> The areas between the sculpture and surround are overgrown with grass and weeds. Archaeological testing could be used to identify and possibly date this unique feature. 	
Well/Cistern (Item 41)	<ul style="list-style-type: none"> A dry-pressed brick well/cistern on the north side of Necropolis Drive was identified during the site inspection (Figure 6.39).

Figure 6.38 Unidentified sculptural feature within No. 1 Anglican Cemetery.

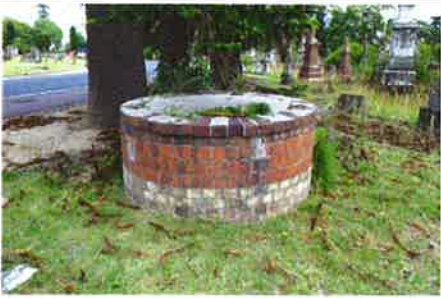
MU #3	<ul style="list-style-type: none"> The top of the well/cistern is sealed with concrete, indicating that it is no longer in use. 	
High archaeological potential	<ul style="list-style-type: none"> There is high potential for the cistern/well to contain sealed artefact deposits associated with use or immediately prior to abandonment. 	
Local significance

Figure 6.39 Well/cistern in Anglican No. 2 cemetery on the north side of Necropolis Drive (visible in the background).

Sealed artefact deposits within the Well/Cistern (Item 41) (if any) would have some archaeological research potential to inform the item's function and date. This archaeological potential would be limited, as any artefacts found would not necessarily prove useful for additional analysis. It would be nearly impossible to determine the dumping habits which would have resulted in their accumulation.

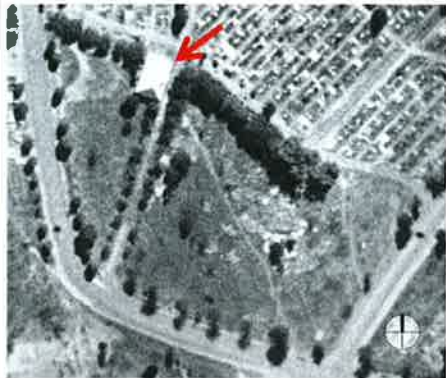
Unidentified Building (Item 42) MU #13C High archaeological potential Local significance	<ul style="list-style-type: none"> A substantial building with a landscaped approach (tree-lined avenue) leading off from north side of Weekes Avenue is visible in a 1943 aerial of Rookwood (Figure 6.40). This site was not identified prior to the site inspection but a contemporary aerial image of the site suggests that the site has not been subject to further disturbance following demolition of this unidentified building (Figure 6.41). This portion of the site retains high archaeological potential for remains of this relatively substantial, landscaped building. Archaeological evidence might include remains of the main structure, outbuildings, sealed artefact deposits associated with use and landscaping features such as gardens, road surfaces/paving, kerbs, drains and fencing. Additional research and archaeological testing would assist with identifying and dating this currently unidentified building. This would assist in further refining the item's significance in relation to Rookwood.

<p>Figure 6.40 Aerial photograph of unidentified building in 1943 (marked with red arrow). (Source: LPI with GML additions 2016)</p>

The archaeological research potential for the Unidentified Building (Item 42) identified in a 1943 aerial photograph of the site is substantial. There appears to have been little or no disturbance to the site since demolition of the building, and in 1943 it featured a double avenue of what appear to be mature trees lining the drive leading toward it from the road (Figure 6.40). Archaeological investigations could assist in identifying this building's age, function and construction techniques used. Sealed artefact deposits associated with it could provide information regarding the people who worked at, lived in or travelled through this structure.

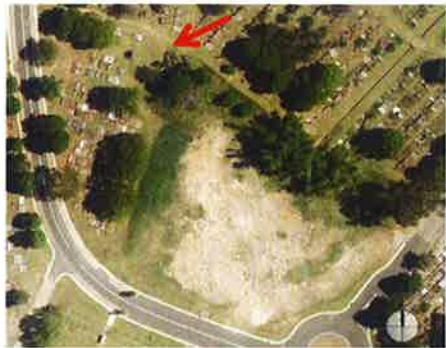
<p>Figure 6.41 Aerial photograph with site of unidentified building c2015 (marked with red arrow). (Source: Google Earth with GML additions 2016)</p>

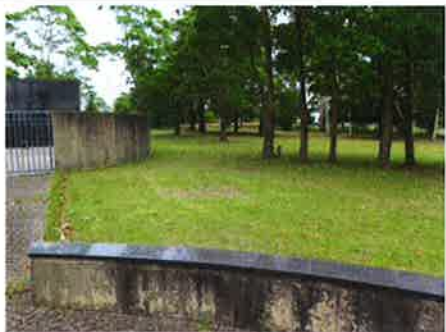
<p>Figure 6.42 Site of the former Jewish receiving building, view to west.</p>

Jewish Receiving Building (Item 43) MU #7 First constructed 1867 Demolished c1970 ¹⁰ High archaeological potential State significance	<ul style="list-style-type: none"> The first Jewish Receiving Building represents one of the original buildings constructed at Rookwood. A review of a 1943 aerial of the study area suggests that it was located in the immediate vicinity of the 'Memorial to the Martyrs of Jewish Persecution in Europe' designed by Harry Seidler and constructed c1970. Archaeological remains of the receiving building may extend to the north and east of the memorial (Figure 6.42). These areas do not appear to have been subject to any disturbance. Depending on the ground disturbance associated with construction of the memorial, archaeological remains of the Jewish Receiving Building may remain in situ beneath it. Archaeological evidence associated with the receiving building might include remains of the main building, outbuildings, sealed artefact deposits associated with use and landscaping features such as gardens, road surfaces/paving, kerbs, drains and fencing.

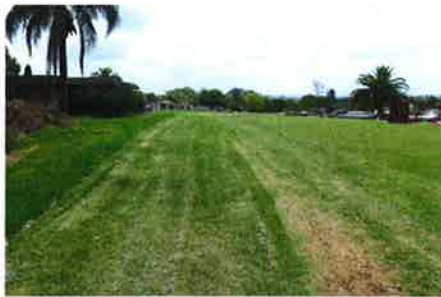
Qualifies as a 'work' under the Heritage Act	<ul style="list-style-type: none"> Parts of the railway corridor which have not yet been disturbed by burials or new infrastructure have moderate potential for archaeological remains most likely comprised of ballast and surfaces used to support the railway tracks and isolated artefacts associated with maintenance of the railway system. 	<p>Figure 6.43 View to the northwest of a section of the railway corridor along the border of MU #9 and MU #13C.</p>

Railway Corridor (Item 44)	<ul style="list-style-type: none"> The railway corridor was established within Rookwood in several stages, with the initial portion extending to Mortuary Station No. 1 by 1868 with further extensions added in 1897 and 1908.

MU #2, #7, #8A, #13A, #13C, #17	<ul style="list-style-type: none"> Use of the railway ceased in 1948 and most of the tracks were removed. 	
First constructed 1867 Demolished 1948	<ul style="list-style-type: none"> A small portion of railway track was retained in situ at the northwest corner of the study area in MU #2. 	
Moderate archaeological potential (MU #7, #8A, #13A, #13C, #17) High archaeological potential (MU #2)	<ul style="list-style-type: none"> This portion of the site has high archaeological potential for remains of the railway track system, including tracks, sleepers, surfaces used to support the railway tracks, remains of rail machinery/other infrastructure, and isolated artefacts associated with maintenance of the railway system.

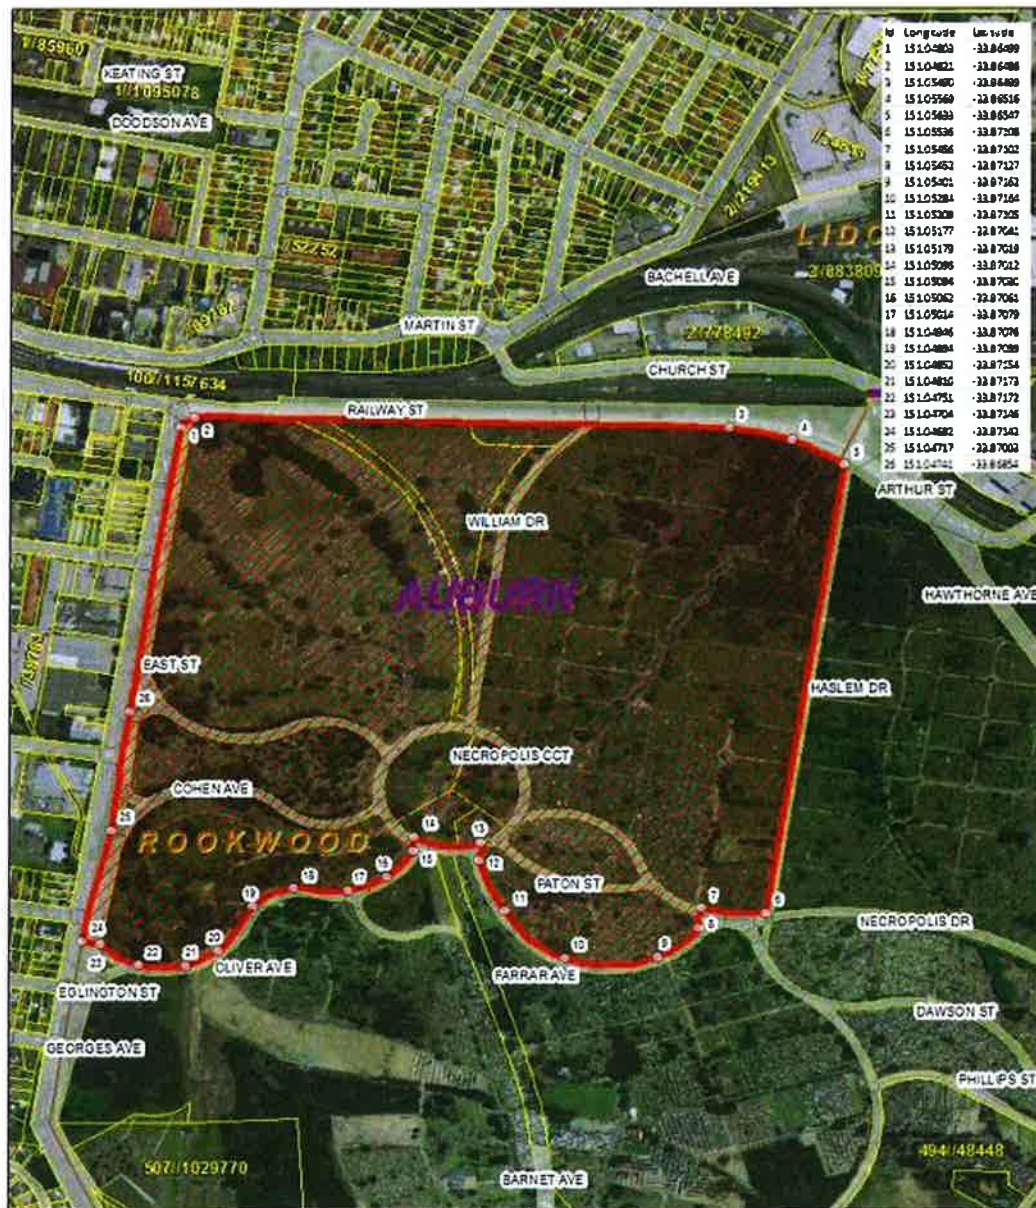
Appendix C—State Heritage Register Curtilage Plan

State Heritage Register - SHR: 00718, Plan:1770 Rookwood Cemetery and Necropolis
